Proposed Distribution Facility Project
7211 and 7219 Morgan Road
Town of Clay, Onondaga County, New York

Exhibit E

Wetlands/Waters Impact Assessment

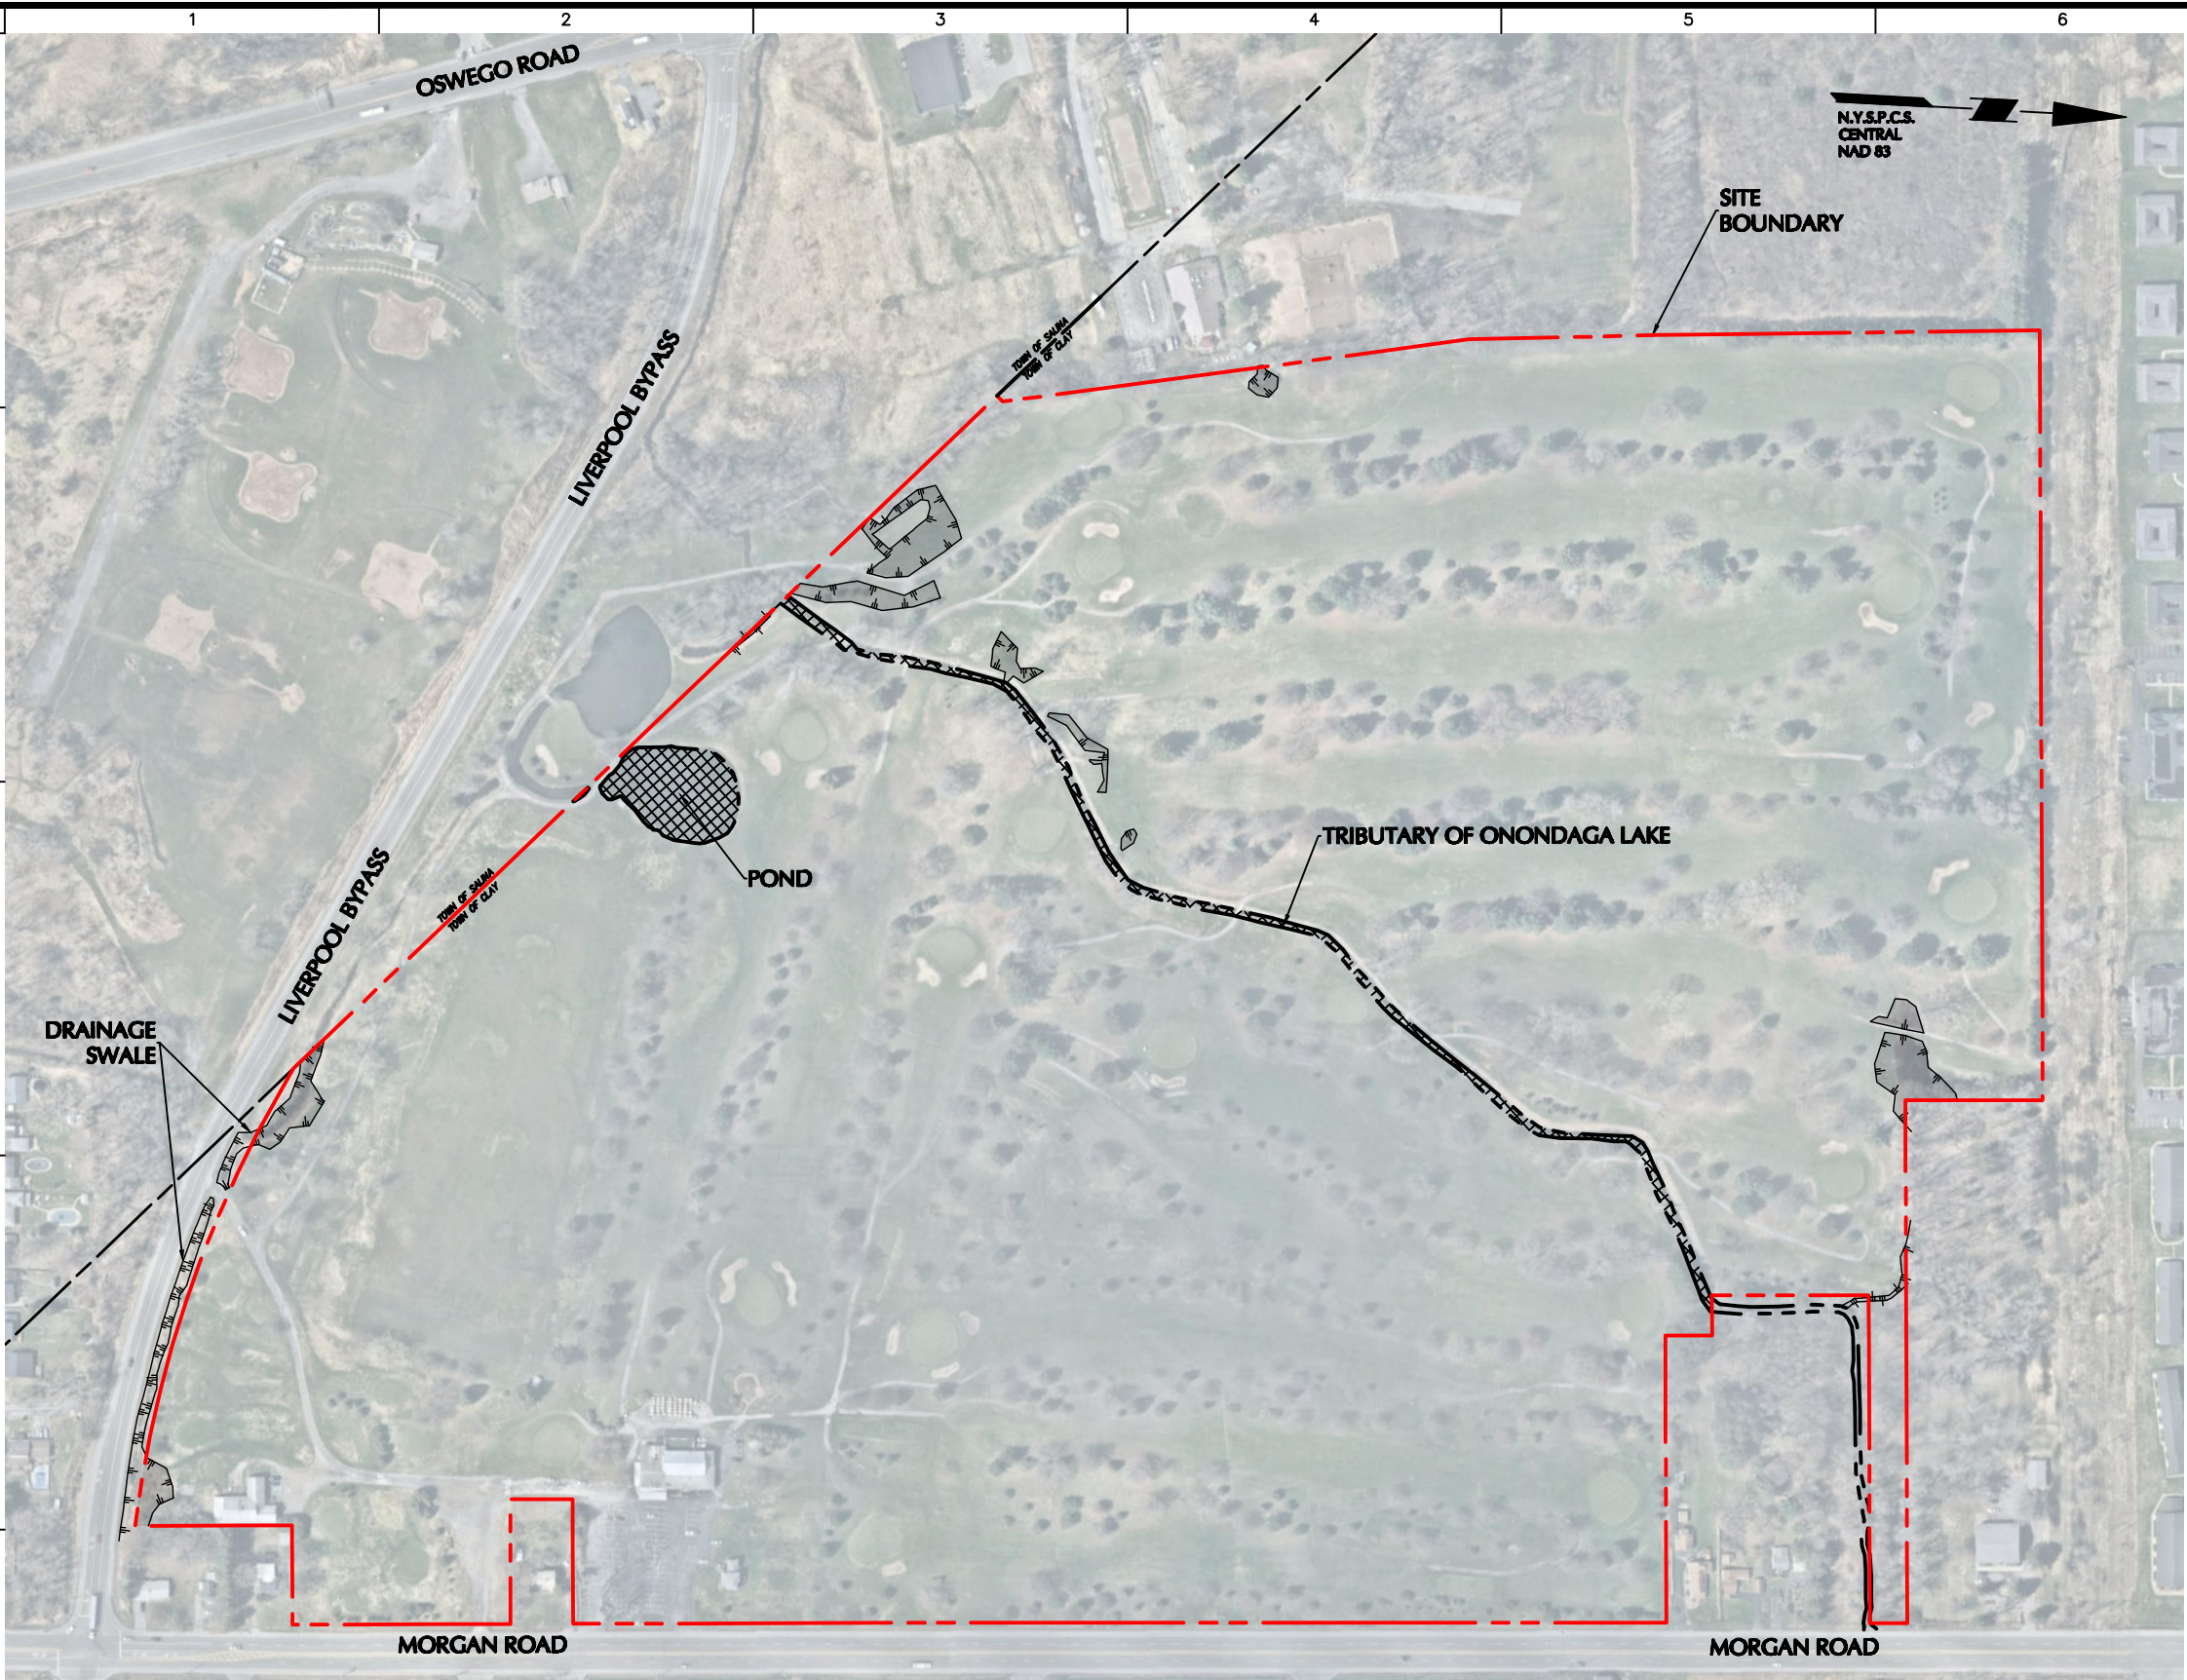
Langan Engineering and Environmental Services, Inc. (Langan) wetland scientists conducted a delineation of wetlands and surface waters located at the project site in July 2019. The delineation was completed in accordance with federal delineation methodology outlined under the U.S. Army Corps of Engineers (USACE) Wetlands Delineation Manual and Northcentral and Northeast Regional Supplement. Delineated features onsite include one (1) stream, one (1) pond and twelve (12) wetland features (see Wetlands/Waters Map - Figure E1).

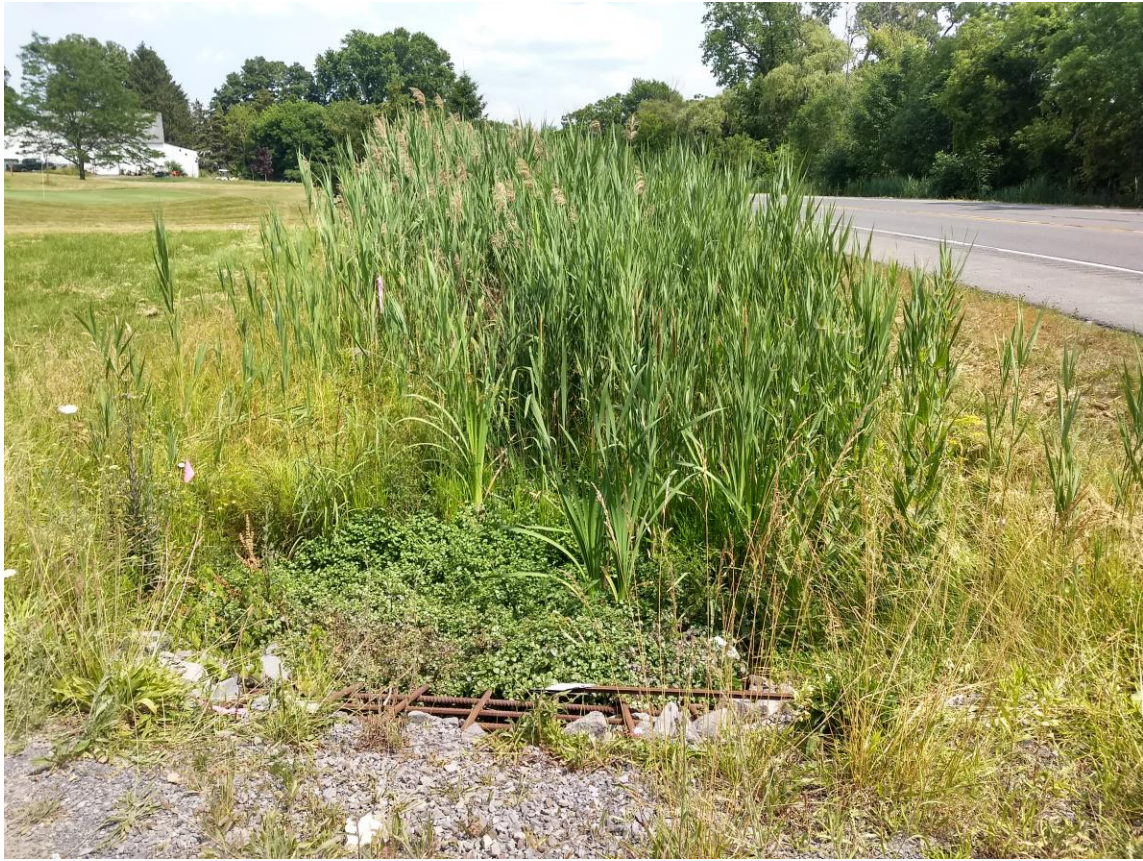
Hydrology – The primary source of hydrology in Wetland B appears to be surface water runoff from the adjacent roadway and upstream drainage network. Wetland B drains westerly and has a hydrologic connection to Wetland C via a 24-inch culvert beneath a gravel access road. Indicators of wetland hydrology observed during the site inspection include: 6" – 10" of standing water, soil saturation at the surface, water marks, sediment deposits, drift deposits, inundation visible on aerial imagery, drainage patterns and microtopographic relief.

Photograph No. 1 – View of Wetland B near flag B22, facing west.

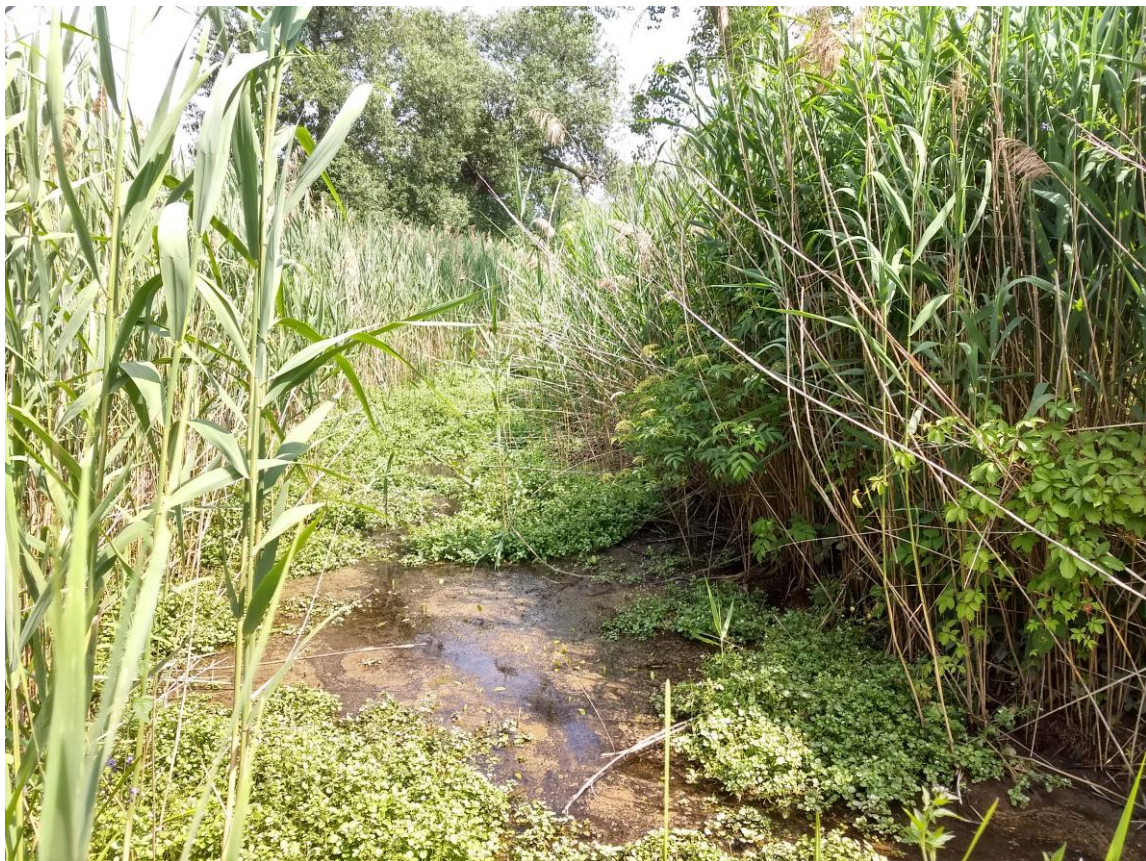
Hydrology – The primary source of hydrology in Wetland C appears to be surface water runoff from the adjacent roadway and the upstream drainage network. Wetland C drains westerly toward Pond D (irrigation pond) and is connected via a 36-inch corrugated metal pipe (CMP) culvert beneath a gravel cart path. Indicators of wetland hydrology observed during the site inspection include: 6” – 10” of standing water, soil saturation at the surface, water marks, sediment deposits, drift deposits, inundation visible on aerial imagery, drainage patterns and microtopographic relief.

Photograph No. 2 – View of Wetland C near flag C17, facing east.

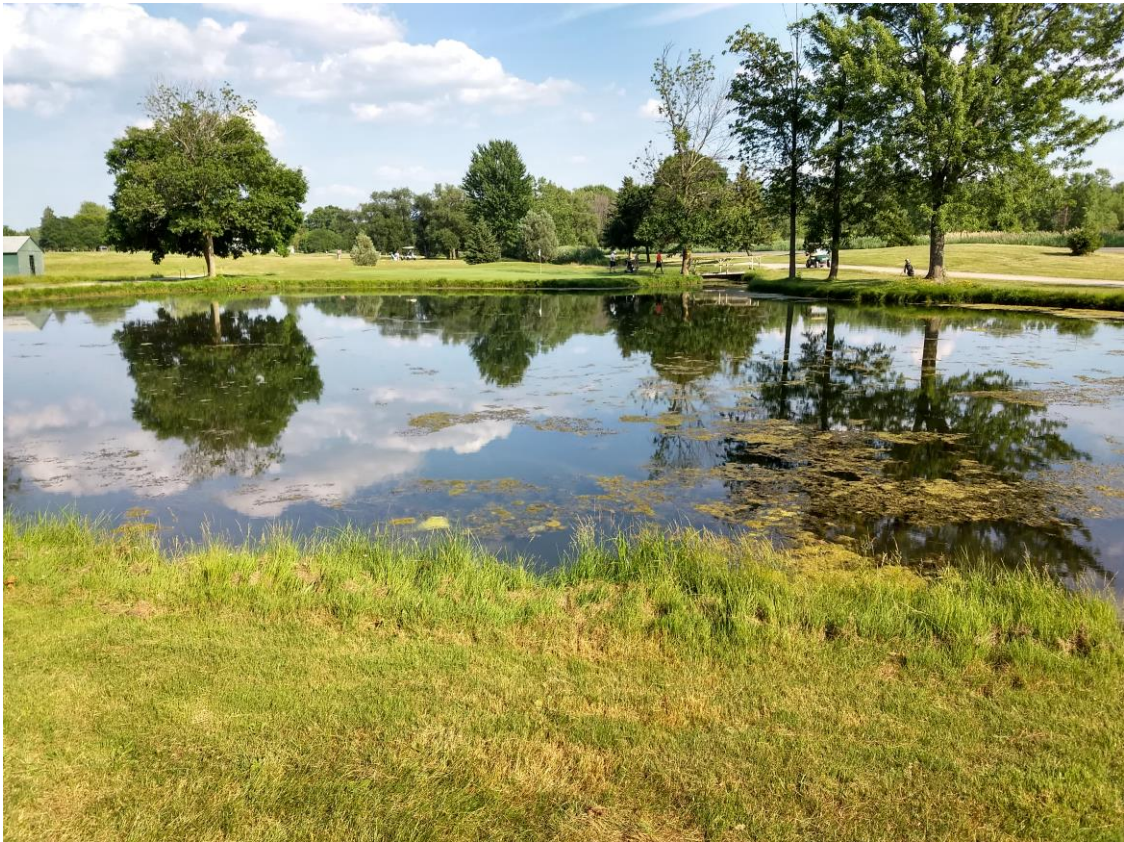
Photograph No. 3 – View of Pond D, facing southeast.

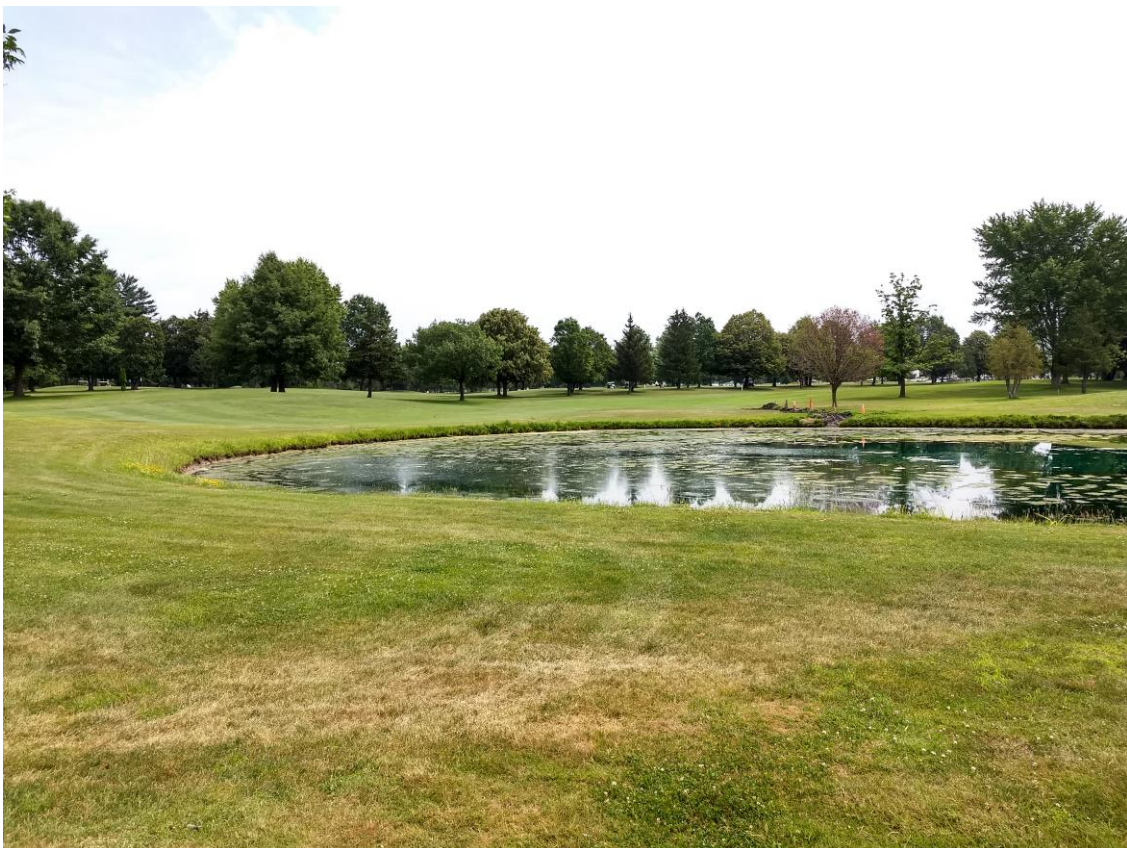
Photograph No. 4 – View of Pond F, facing east.

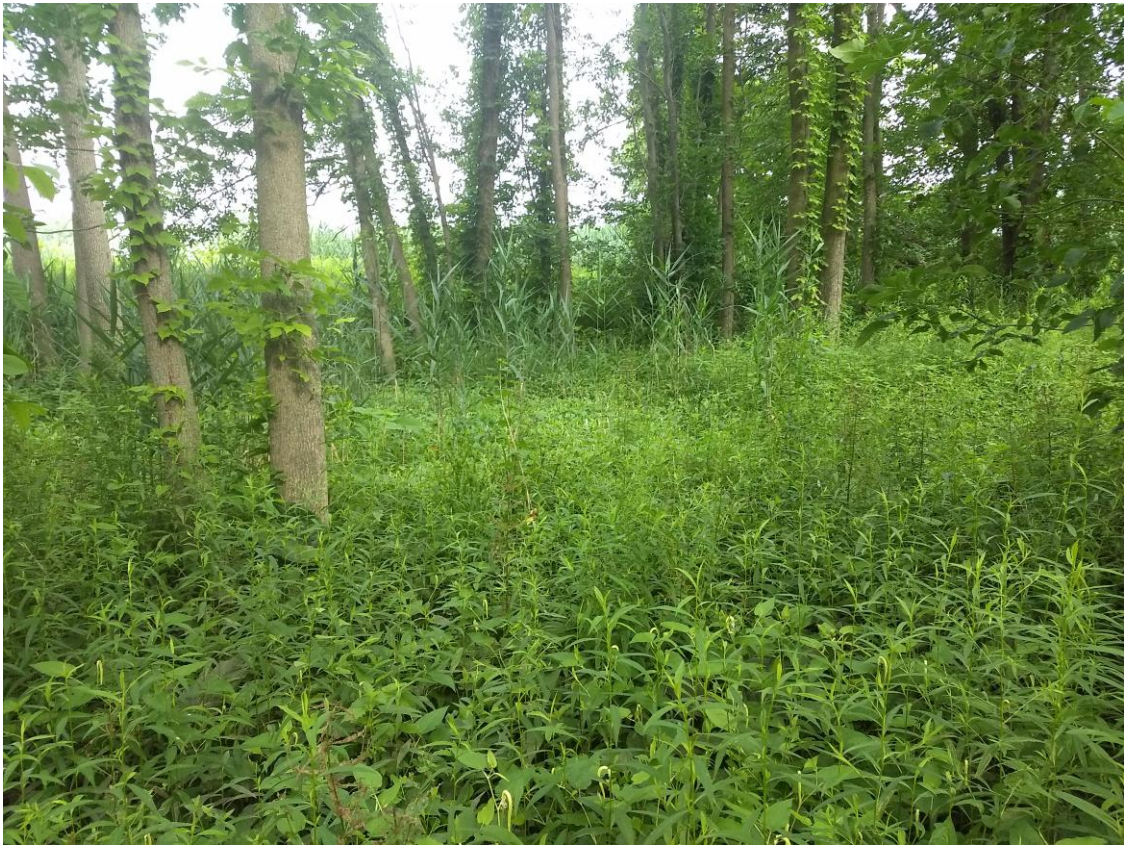
Hydrology – The primary source of wetland hydrology in Wetland E appears to be streamflow and occasional floodwaters from the Tributary of Onondaga Lake (Stream A). A secondary source of hydrology in Wetland E is attributed to surface water runoff from the adjacent roadway and surrounding uplands. Indicators of wetland hydrology observed during the site inspection include: 6” – 10” of standing water, soil saturation at the surface, water marks, sediment deposits, drift deposits, inundation visible on aerial imagery, drainage patterns and microtopographic relief.

Photograph No. 5 – View of forested portion of Wetland E near flag E34, facing south.

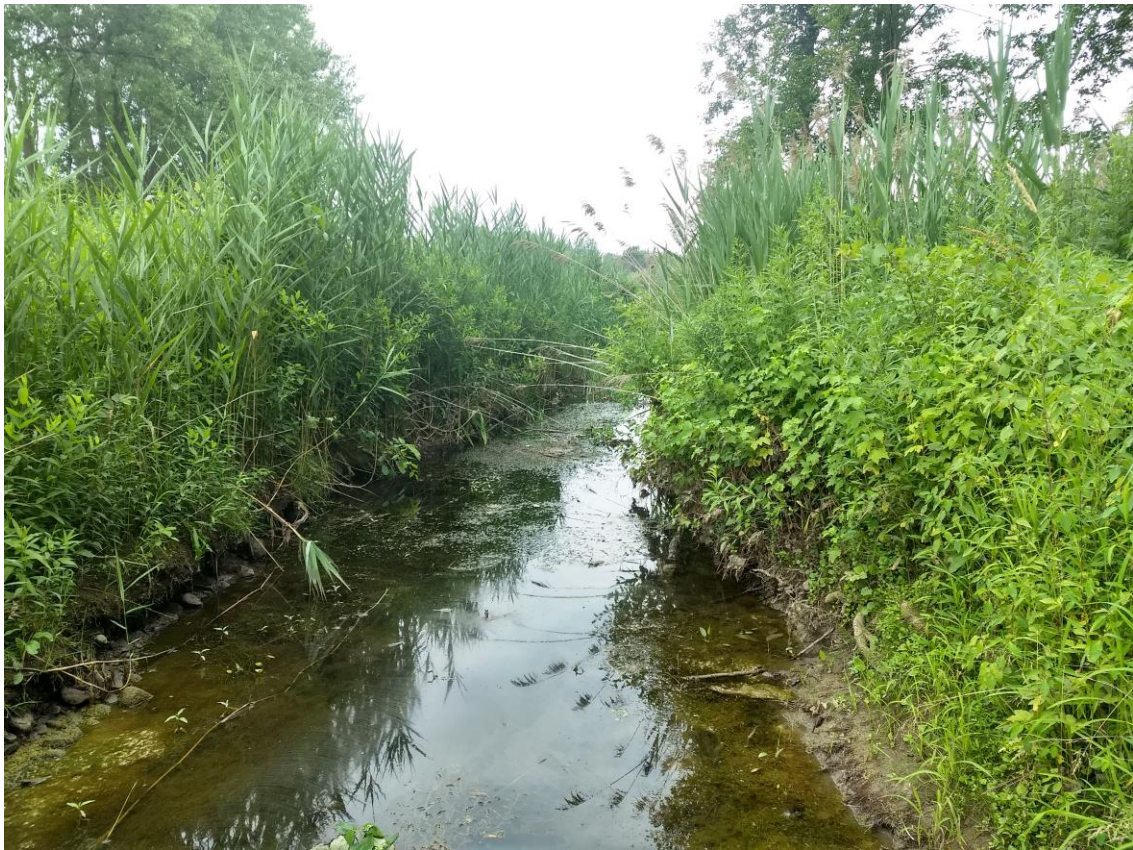
Photograph No. 6 – View of Tributary of Onondaga Lake along the southern site boundary.

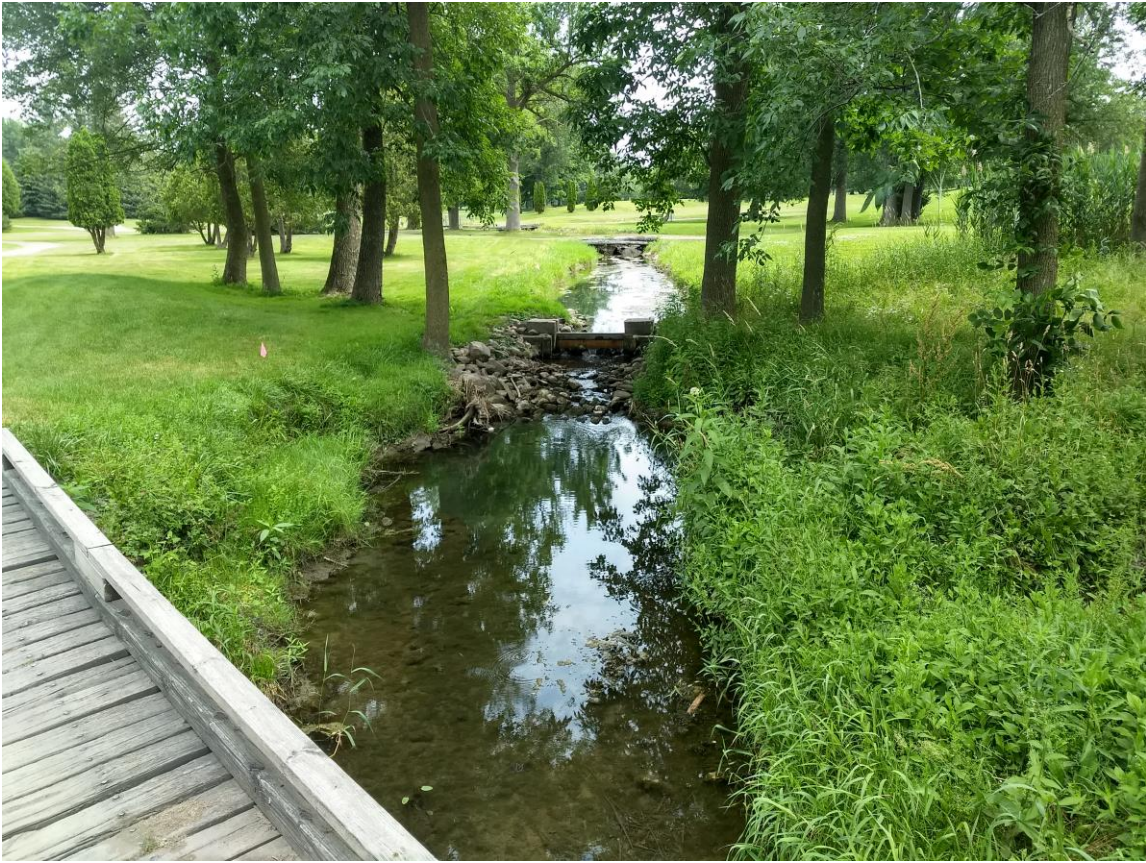
The onsite stream, a Tributary of Onondaga Lake, totals approximately 2,000 linear feet and generally bisects the property from northeast to southwest. The stream channel has been historically modified and is surfaced with rip-rap and concrete. The stream is identified by the New York State Department of Environmental Conservation (NYSDEC) as a Class B water, and is therefore considered a protected stream under the NYSDEC Protection of Waters Program. An irrigation pond totaling approximately 0.5 acres is present along the southern site boundary. The pond appears to be a man-made feature constructed sometime between 1960 and 1966.

Photograph No. 7 – View of Stream A (Tributary of Onondaga Lake) near flag G2, facing north.

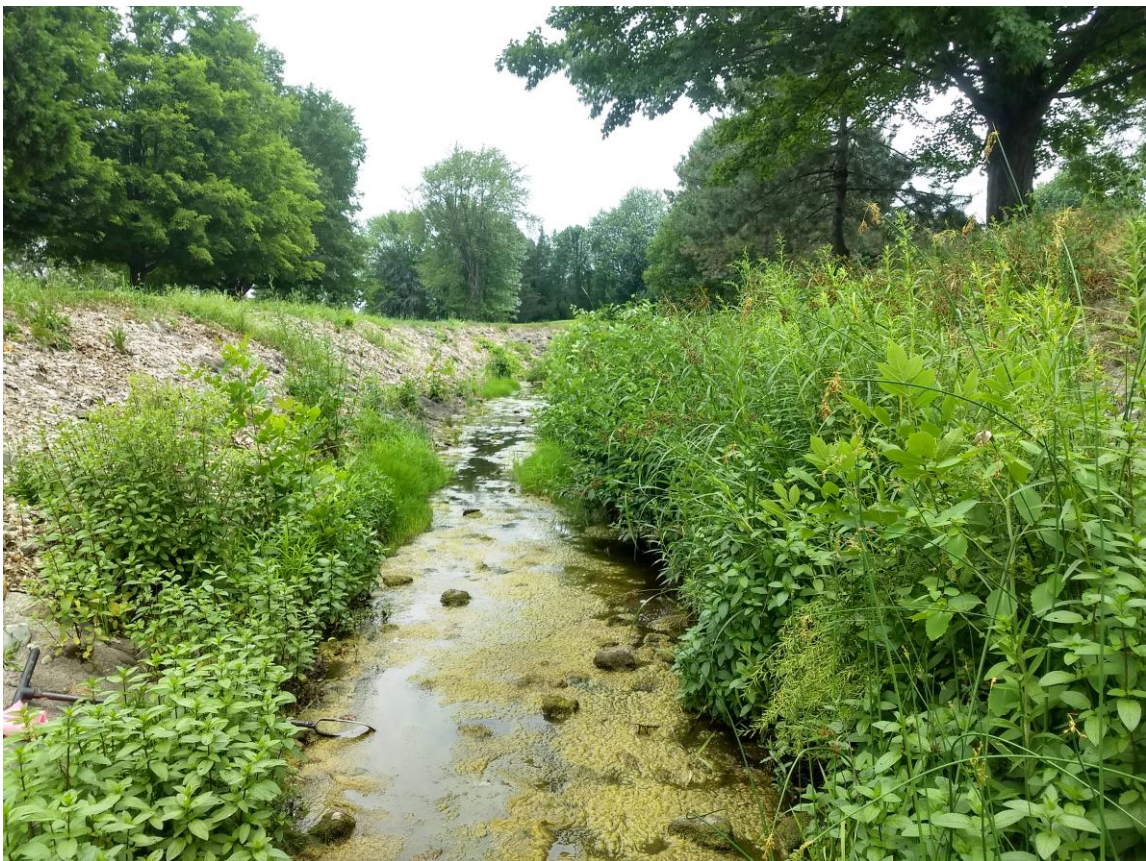
Photograph No. 8 – View of Stream A (Tributary of Onondaga Lake) near flag G61, facing north.

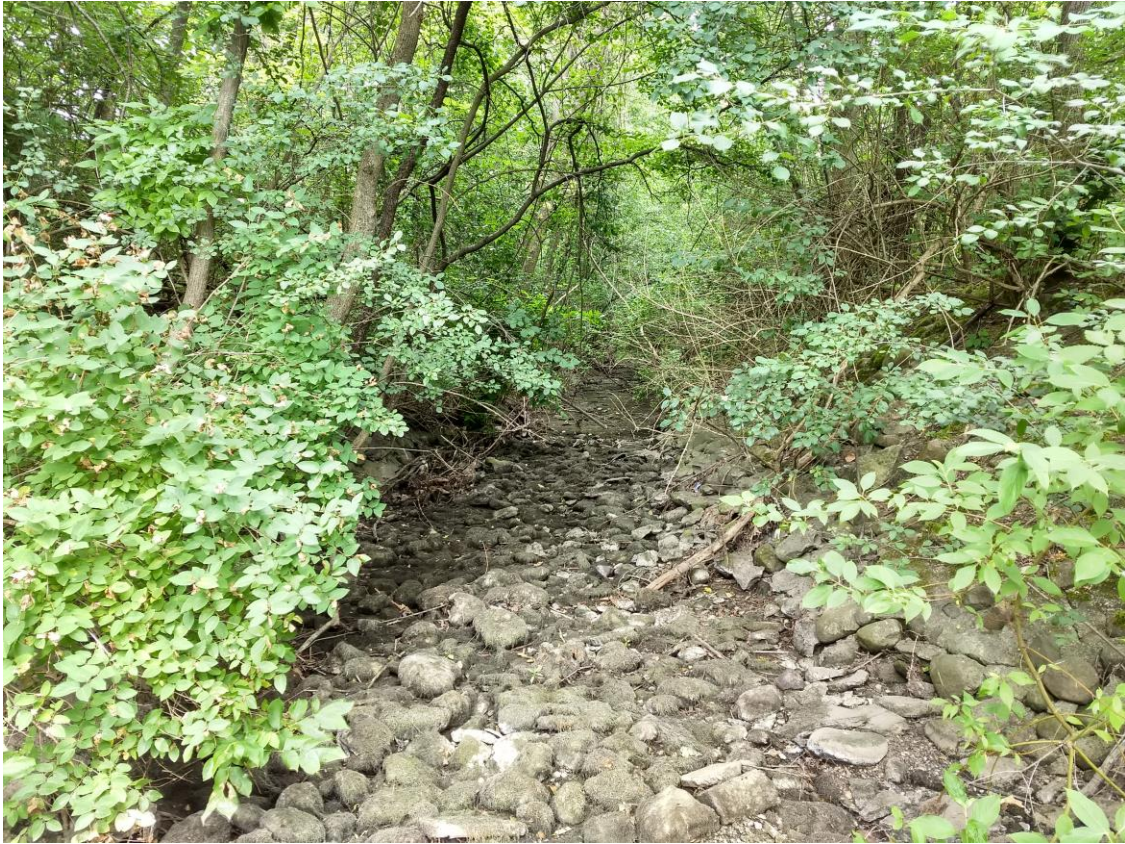
Photograph No. 9 – View of Stream A (Tributary of Onondaga Lake) near flag G82, facing east.

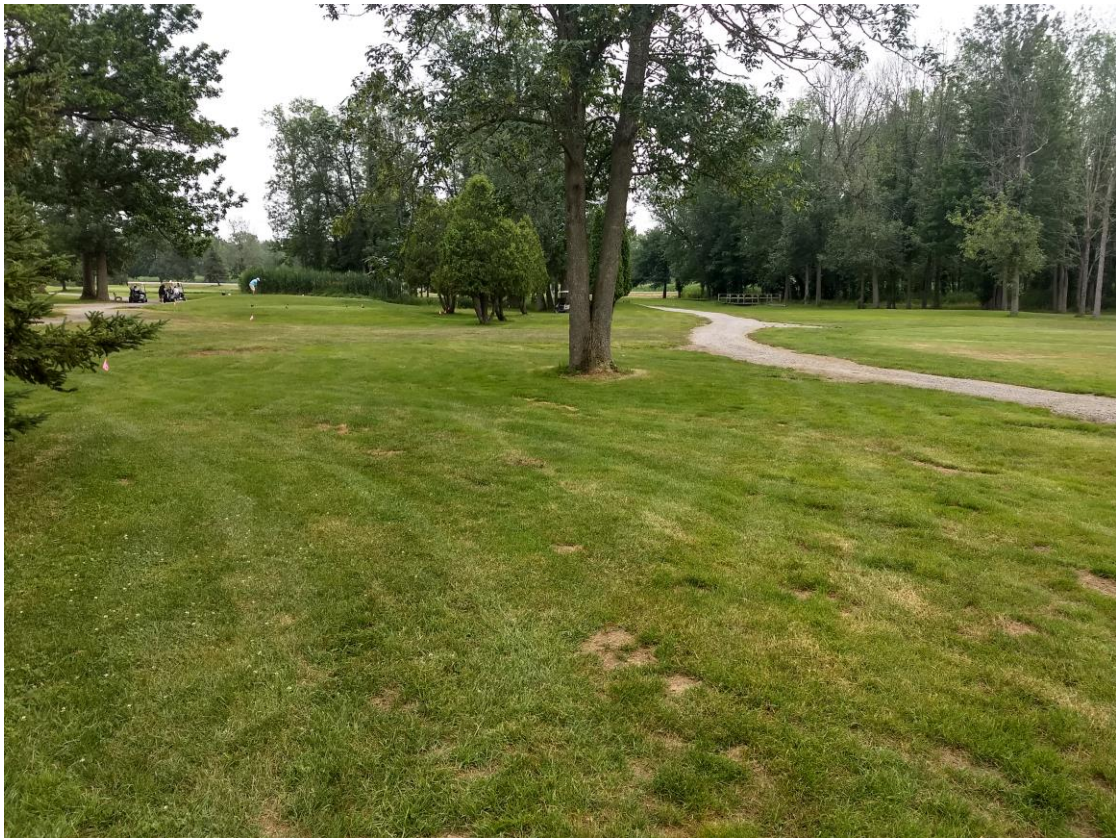
Photograph No. 10 – View of Wetland H near flag H7, facing south.

Field Observations: Surface Water Present? Yes _____ No <u>X</u> Depth (inches): <u>N/A</u> Water Table Present? Yes _____ No <u>X</u> Depth (inches): <u>N/A</u> Saturation Present? Yes _____ No <u>X</u> Depth (inches): <u>N/A</u> (includes capillary fringe)	Wetland Hydrology Present? Yes <u>X</u> No _____	
Describe Recorded Data (stream gauge, monitoring well, aerial photos, previous inspections), if available:		
Remarks: Indicators of wetland hydrology observed during the site inspection include: water marks, sediment deposits, sparsely vegetated concave surface, drainage patterns and microtopographic relief. Wetland H drains directly into Stream A via overland flow.

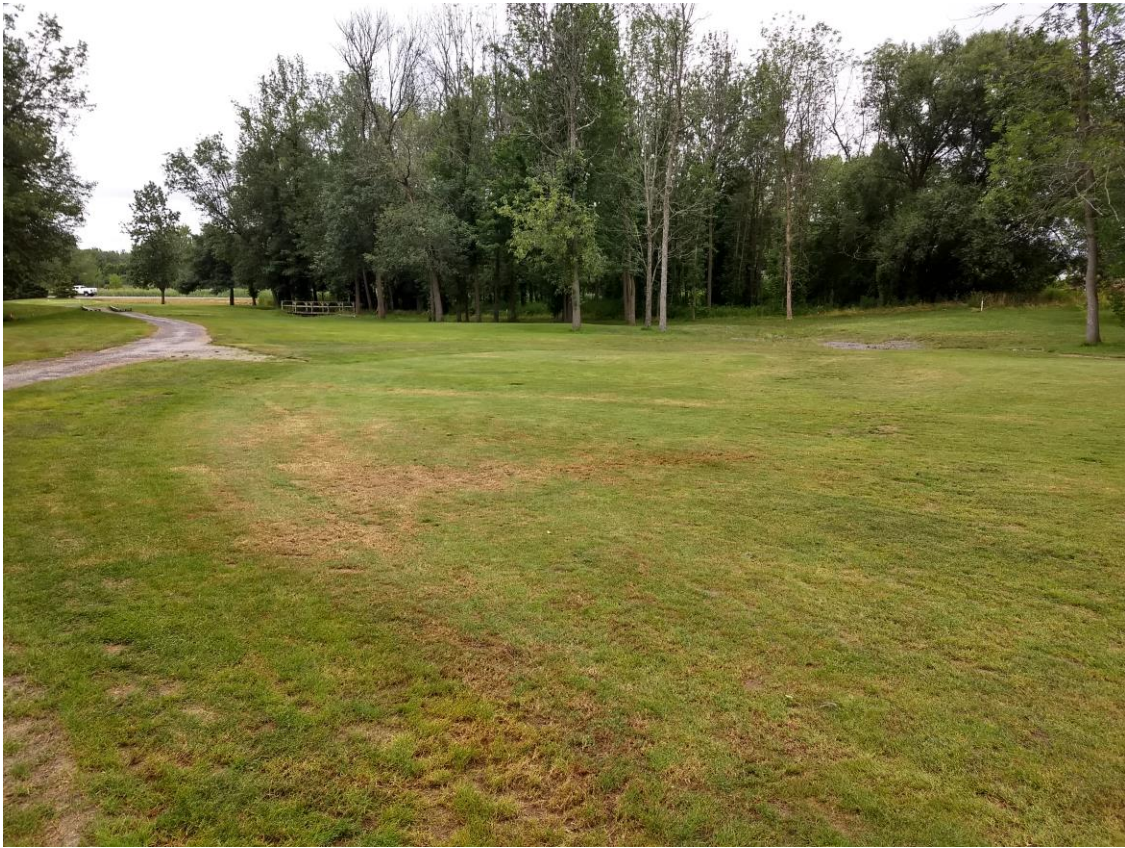
Photograph No. 11 – View of Wetland I near flag I10, facing south.

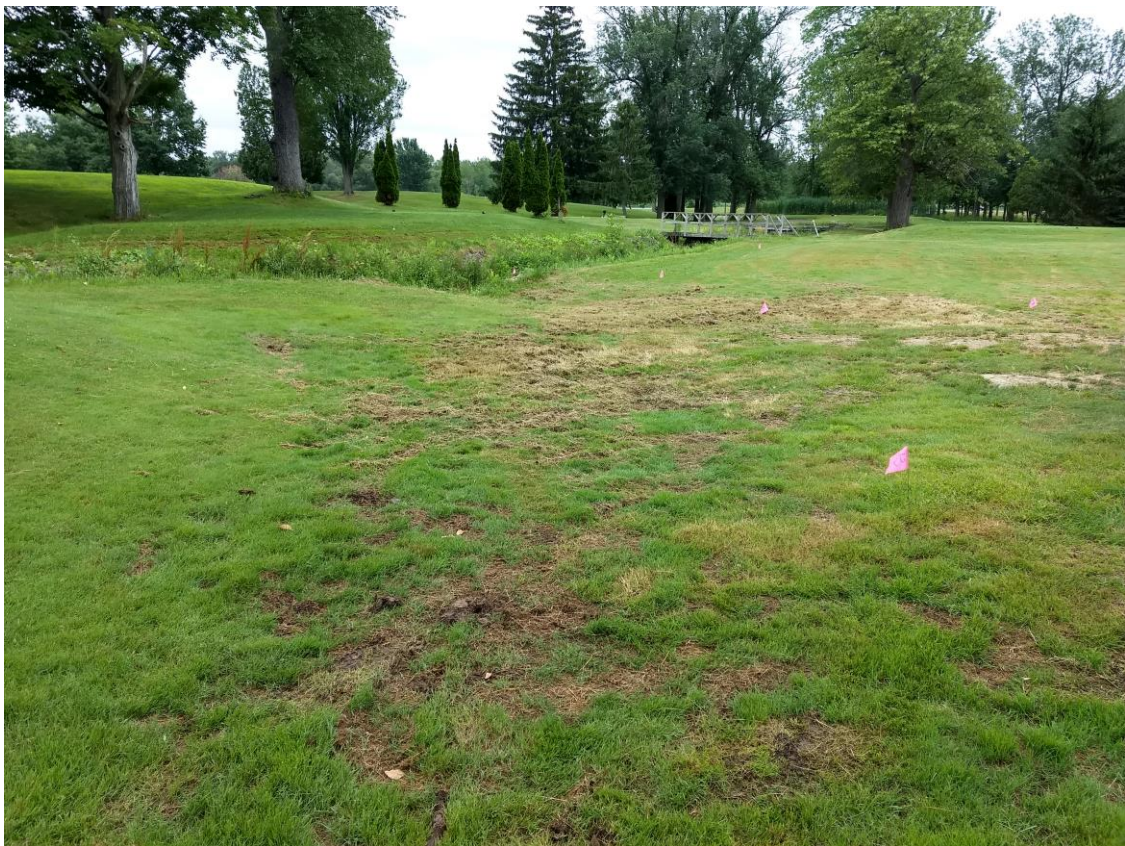
Photograph No. 12 – View of Wetland J near flag J10, facing south.

Field Observations: Surface Water Present? Yes _____ No <u>X</u> Depth (inches): <u>N/A</u> Water Table Present? Yes _____ No <u>X</u> Depth (inches): <u>N/A</u> Saturation Present? Yes <u>X</u> No _____ Depth (inches): <u>At Surface</u> (includes capillary fringe)	Wetland Hydrology Present? Yes <u>X</u> No _____	
Describe Recorded Data (stream gauge, monitoring well, aerial photos, previous inspections), if available:		
Remarks: Indicators of wetland hydrology observed during the site inspection include: soil saturation at the surface, water marks, sediment deposits, drainage patterns and microtopographic relief. Wetland J drains via overland flow into Stream A.

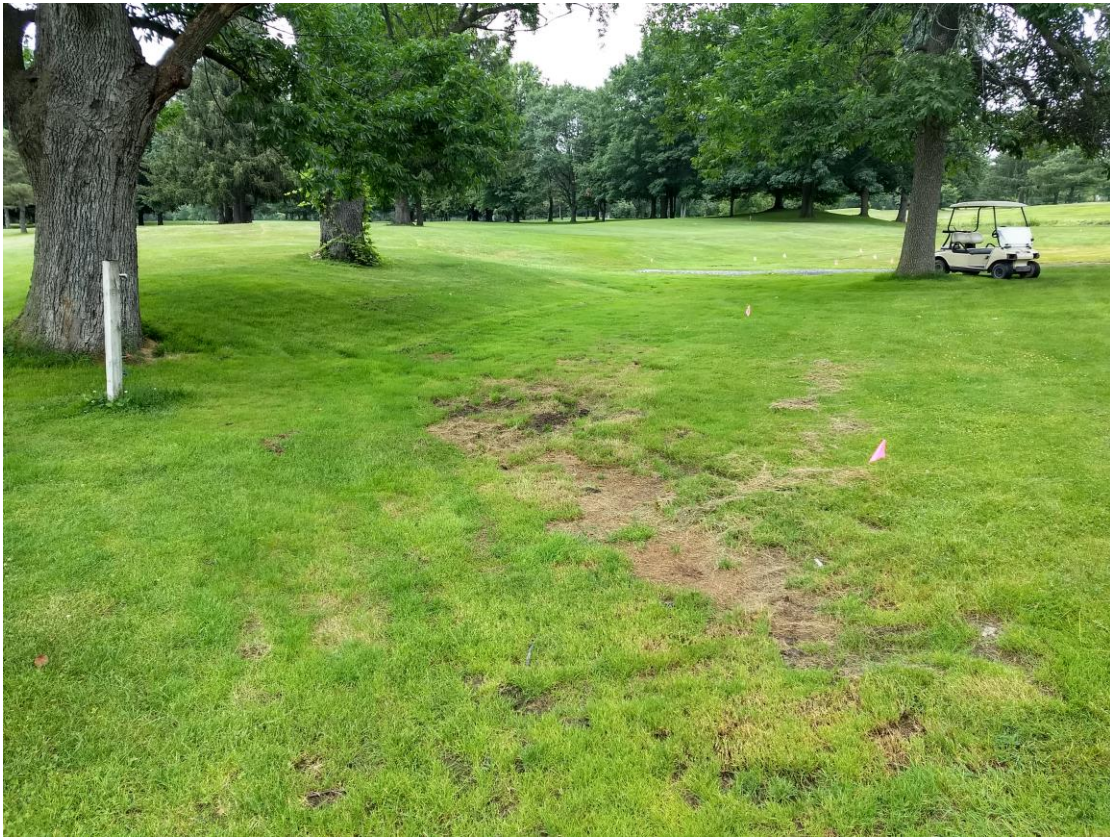
Photograph No. 13 – View of Wetland K near flag K13, facing northeast.

Field Observations: Surface Water Present? Yes _____ No <u>X</u> Depth (inches): <u>N/A</u> Water Table Present? Yes _____ No <u>X</u> Depth (inches): <u>N/A</u> Saturation Present? Yes <u>X</u> No _____ Depth (inches): <u>At Surface</u> (includes capillary fringe)		Wetland Hydrology Present? Yes <u>X</u> No _____	
Describe Recorded Data (stream gauge, monitoring well, aerial photos, previous inspections), if available:			
Remarks: Indicators of wetland hydrology observed during the site inspection include: soil saturation at the surface, water marks, sediment deposits, sparsely vegetated concave surface, drainage patterns and microtopographic relief. Wetland K drains into Stream A via two 8-inch CMP inlet/drainage pipe.

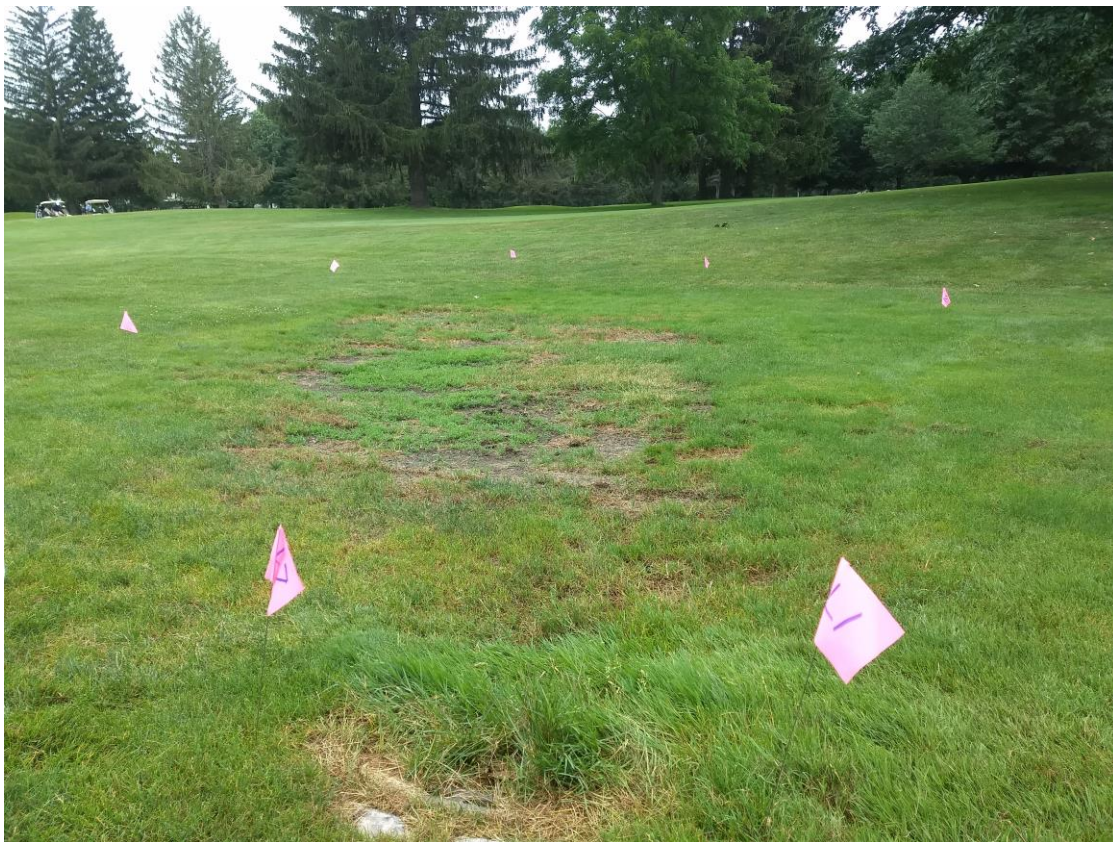
Photograph No. 14 – View of Wetland L near flag L7, facing north.

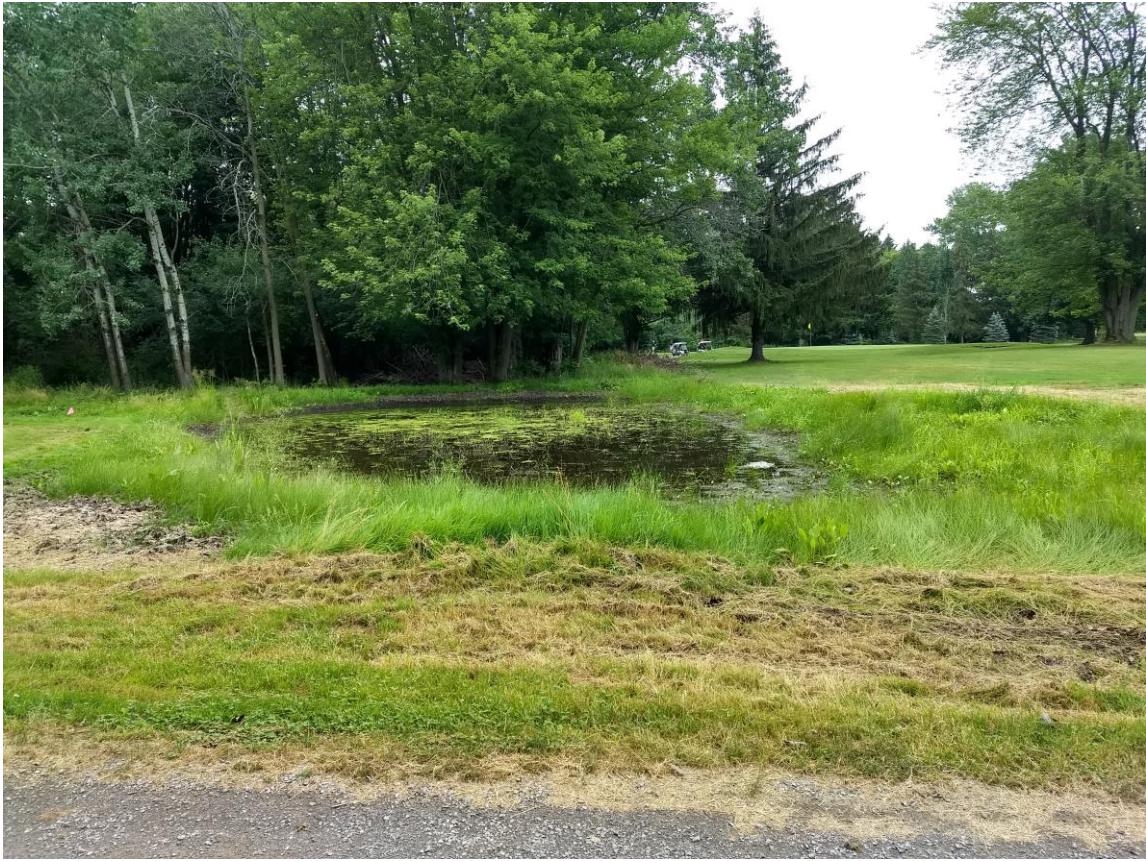
Hydrology – The primary source of wetland hydrology in Wetland M appears to be surface water runoff from surrounding upland areas. The wetland appears to be an isolated depression with no evident surface water connection to any other wetlands/waters. Indicators of wetland hydrology observed during the site inspection include: 4 – 6 inches of standing water, soil saturation at the surface, water marks, sediment deposits, inundation visible on aerial imagery, water-stained leaves, aquatic fauna and microtopographic relief.

Photograph No. 15 – View of Wetland M near flag M6, facing east.

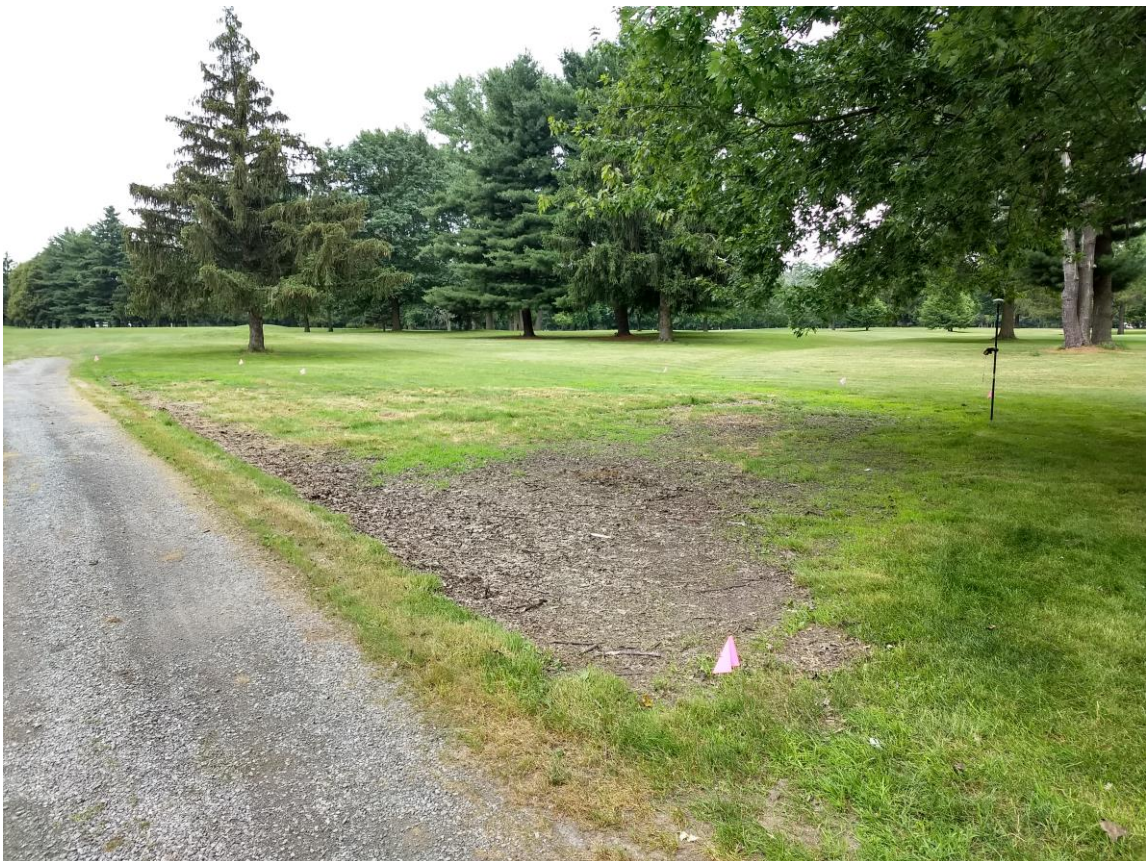
Hydrology – The primary source of wetland hydrology in Wetland N appears to be surface water runoff from surrounding upland areas. The wetland appears to be an isolated depression with no evident surface water connection to any other wetlands/waters. Indicators of wetland hydrology observed during the site inspection include: water marks, sediment deposits, sparsely vegetated concave surface, water-stained leaves, surface soil cracks and microtopographic relief.

Photograph No. 16 – View of Wetland N near flag N6, facing east.

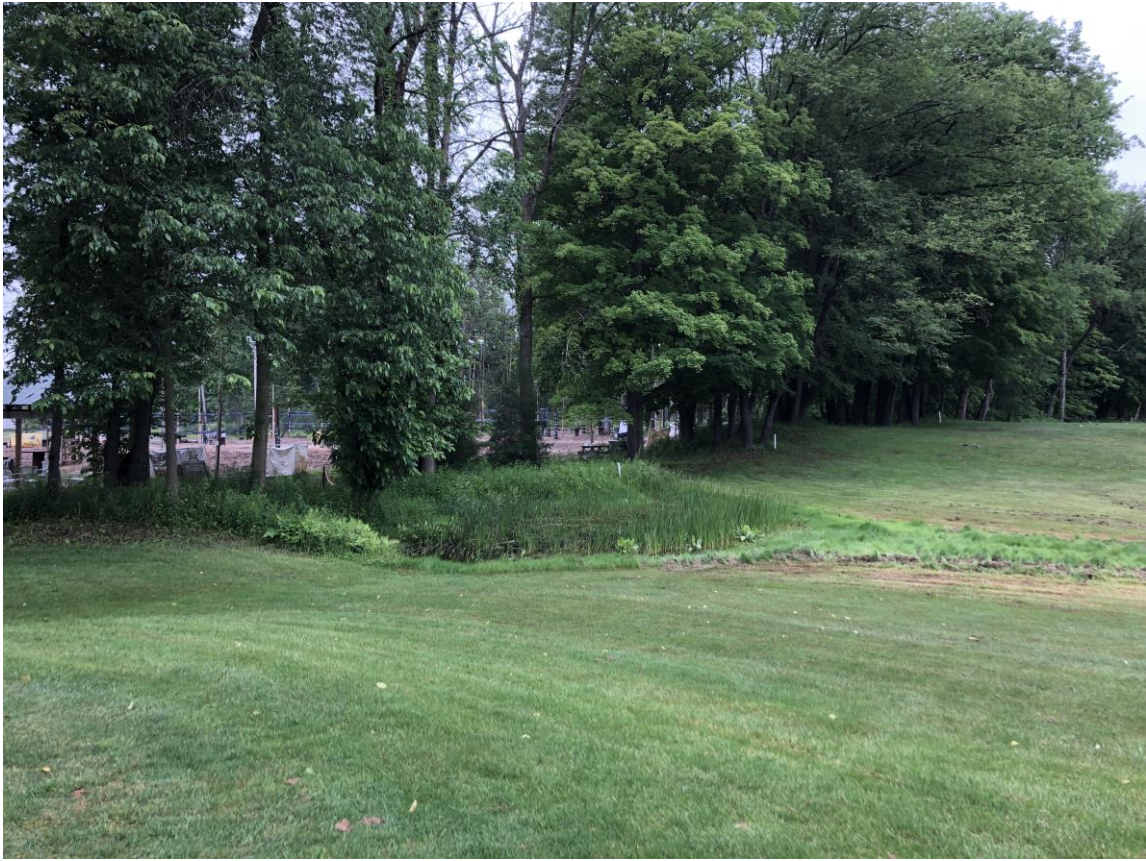
Hydrology – The primary sources of hydrology in Wetland P appear to be surface water runoff from surrounding upland areas and groundwater. Wetland P appears to be isolated from other wetlands/waters. Indicators of wetland hydrology observed during the site inspection include: 4 – 6 inches of standing water, water marks, sediment deposits, inundation visible on aerial imagery, water-stained leaves and microtopographic relief.

Photograph No. 17 – View of Wetland P near flag P4, facing west.
