Proposed Distribution Facility Project
7211 and 7219 Morgan Road
Town of Clay, Onondaga County, New York

Exhibit E

Wetlands/Waters Impact Assessment

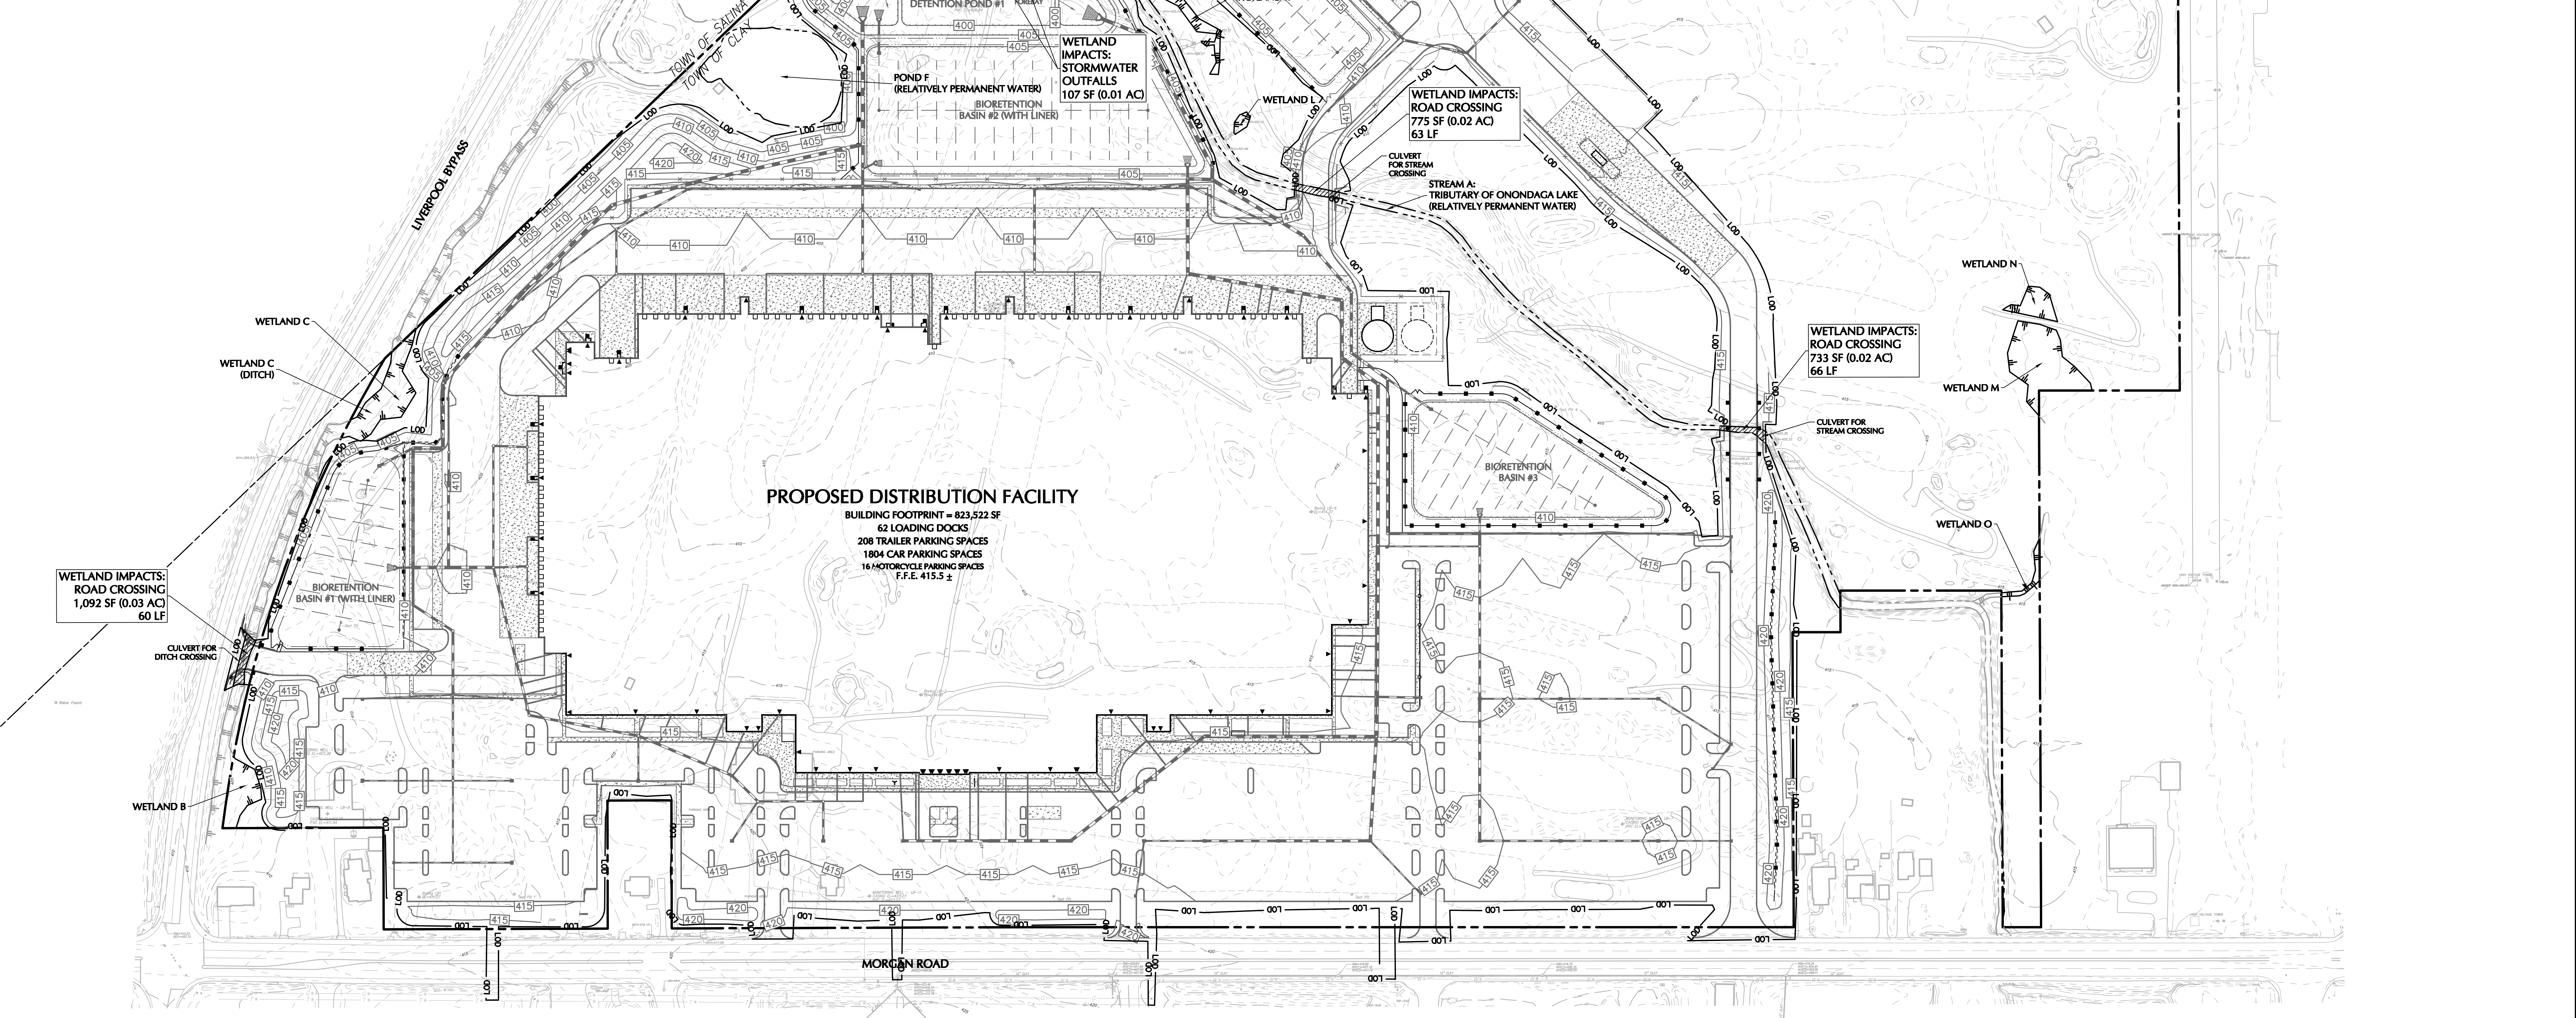
Drawing No.
WP100

3. ELEVATIONS SHOWN ARE REFERENCED TO THE NORTH AMERICAN VERTICAL DATUM OF 1988 (NAVD 88).
4. WETLANDS AND WATERS WERE DELINEATED ONSITE BY LANGAN ENGINEERING, ENVIRONMENTAL, SURVEYING, LANDSCAPE ARCHITECTURE AND GEOLOGY, D.P.C. WETLAND SCIENTISTS BETWEEN 10 - 12 JULY 2019. WETLAND FLAG LOCATIONS SHOWN HEREON HAVE BEEN OBTAINED USING FIELD PROCEDURES THAT INCLUDE CODE-ONLY GPS/GNSS COMPATIBLE UNITS WITH EXTERNAL ANTENNAS AND OFFICE PROCEDURES THAT INCLUDE POST-PROCESSING OF THE COLLECTED FIELD DATA.
