# **Micron Central New York Semiconductor Manufacturing Complex**

## **Buxton Creek Stream and Wetland Mitigation Plan**

**Oswego County, NY**

**May 2025**

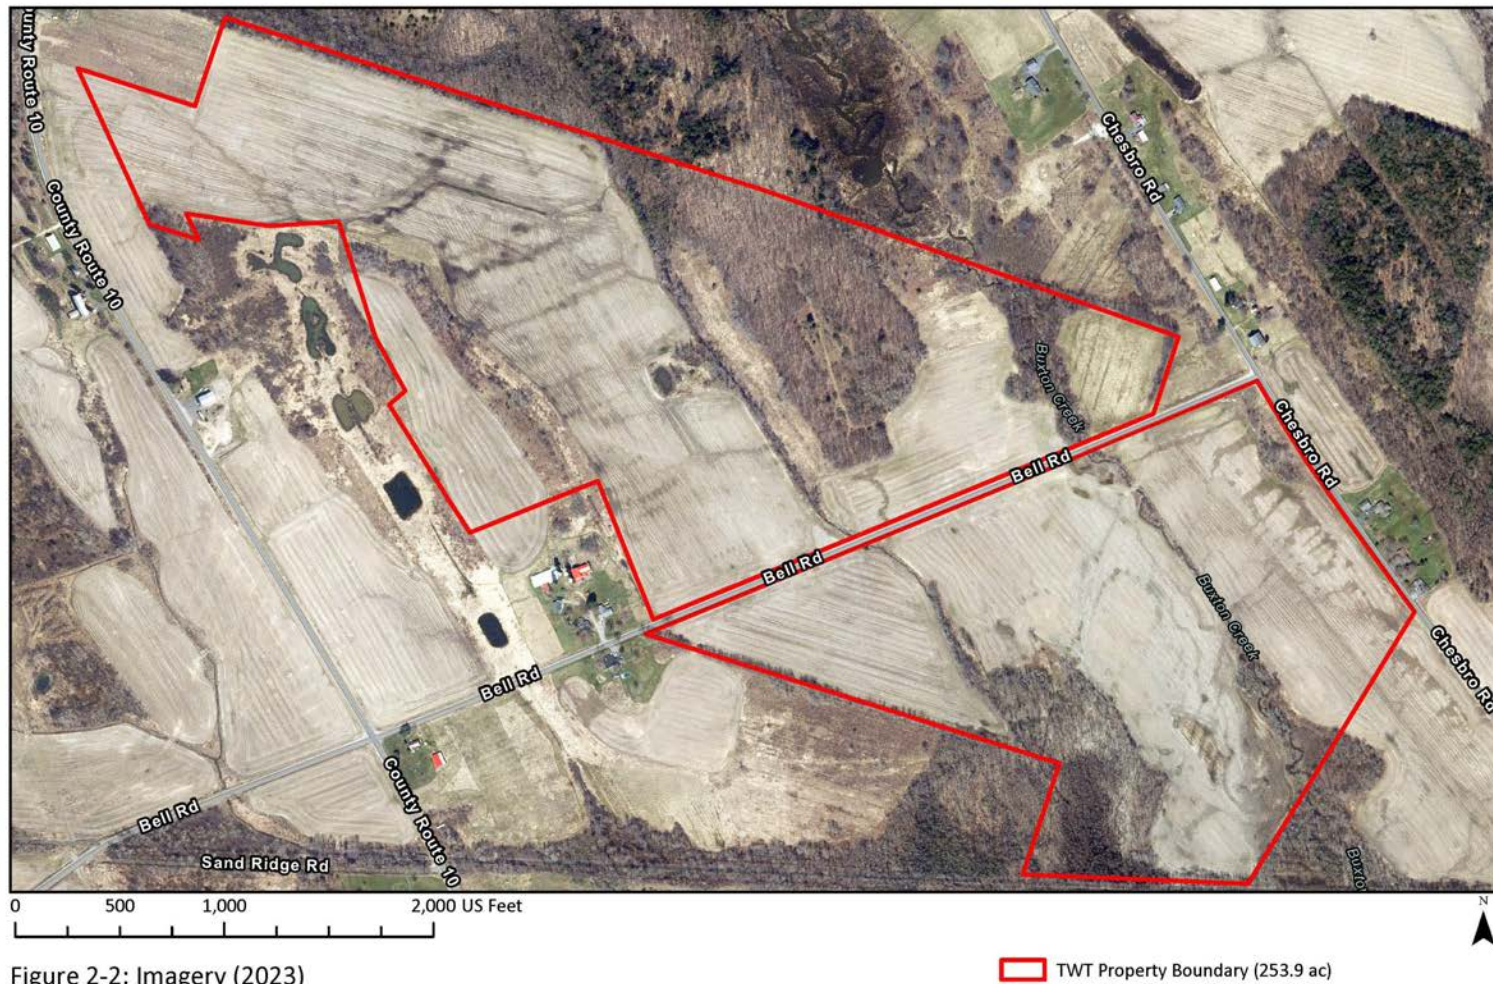
**Figure 2-2.** Buxton Creek Property (2023)

The Buxton Creek Site is approximately 253.9 acres in size in the Town of Schroepel, Oswego County, New York (**Figure 2-1**). The Site is within the Oneida River 12-digit HUC (041402020905) watershed, and the U.S. Geological Survey 7.5-minute quadrangle indexed as Central Square. Coordinates for the approximate center of the Site are: [43.28625145, -76.23092591]. The Site is bisected by Bell Road and west of Chesbro Road (**Figure 2-2**).

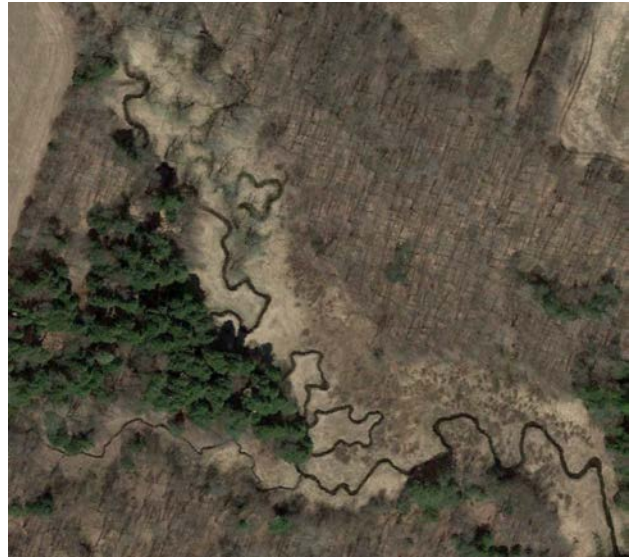
**Figure 8-1d.** Reference Reach #3 Bell Creek

Local streams that have not been relocated, channelized, placed underground, affected by head cuts, or otherwise heavily altered were used to inform the design of the mitigation streams. Key reference streams were portions of Fish Creek, Bell Creek, and Sixmile Creek as shown in **Figures 8-1a-e**. Reference reach #1 (**Figure 8-1b**) is most proximate to the Buxton Creek property to the northwest. The imagery shows a stream that is braided with a complex of wetlands on nearly level ground. Bell Creek and Sixmile Creek references reaches #2-4 (**Figures 8-1c-e**) exemplify the sinuosity and presence of wetlands on the floodplain of natural streams in the area.

Imagery: 2017, Location: 43.334094 -76.356244

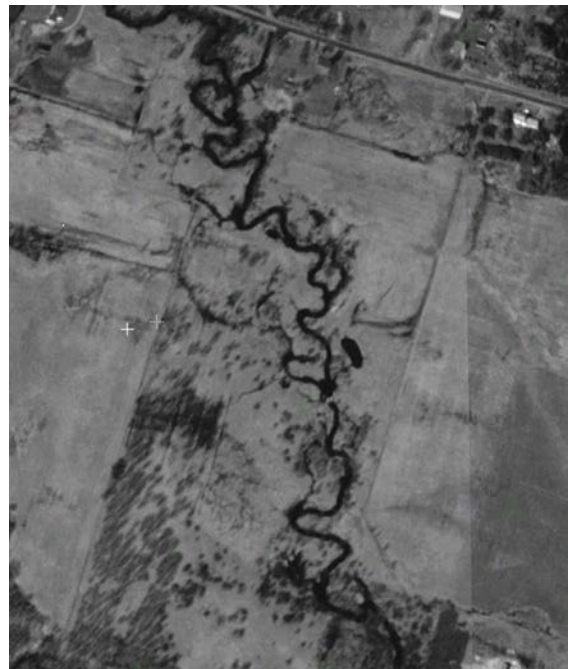
**Figure 8-1e.** Reference Reach #4 Sixmile Creek

Imagery: 1994, Location: 43.311918, -76.310130

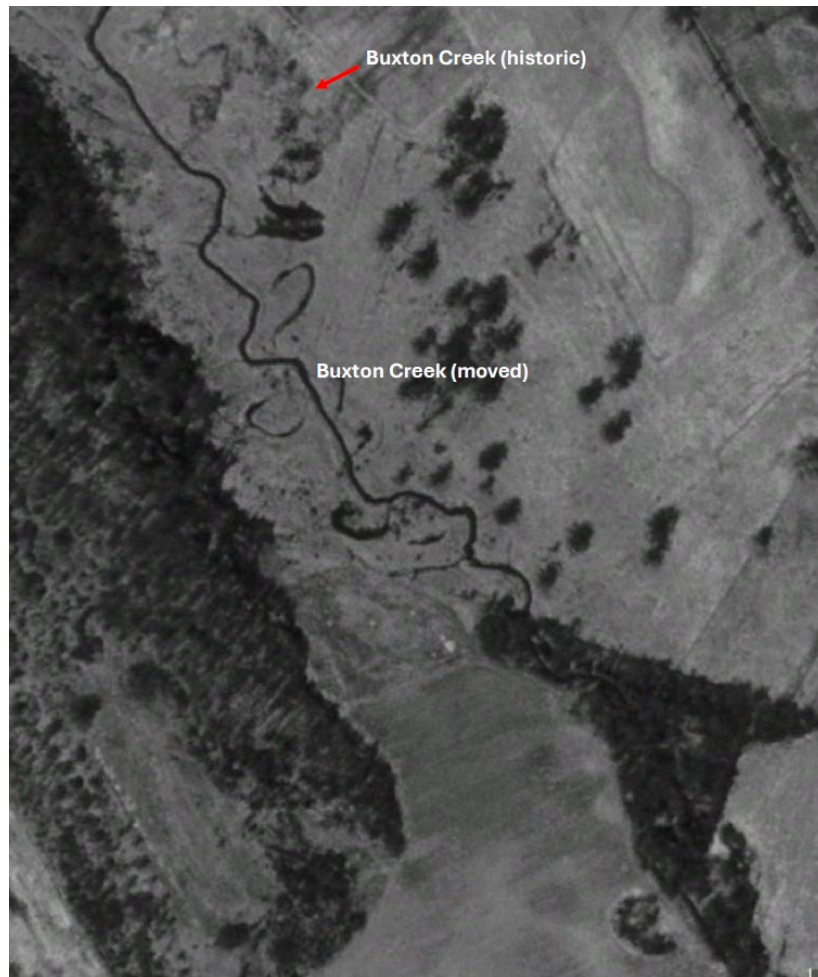
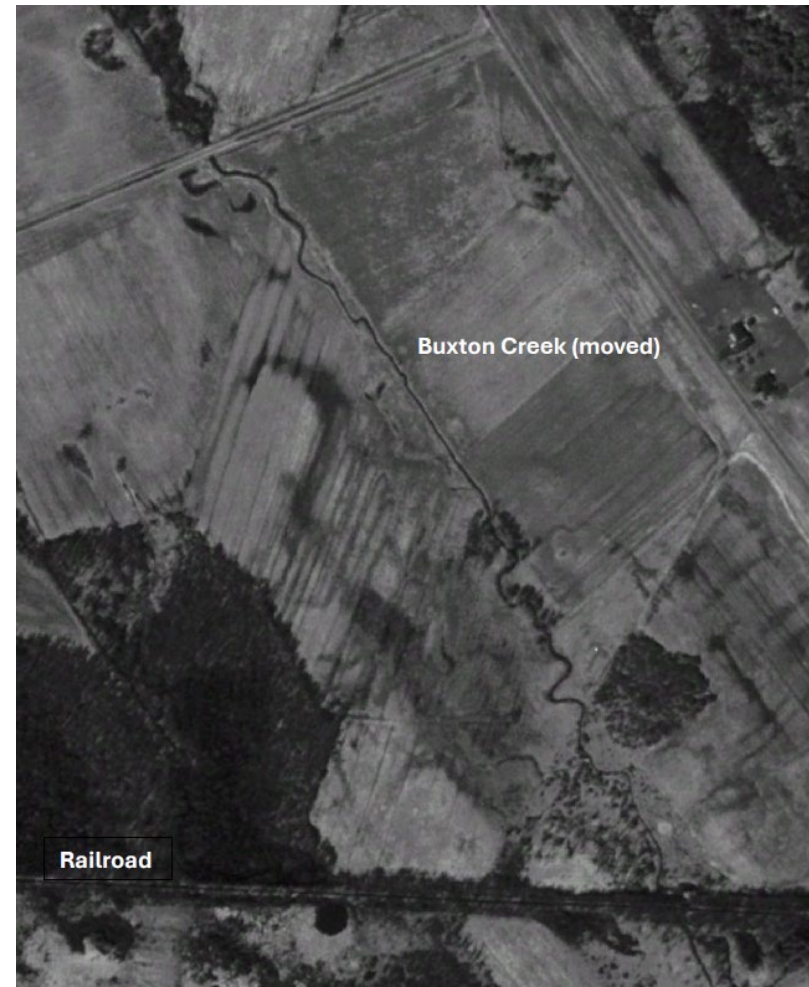
**Figure 8-2a.** Buxton Creek North of Bell Road

**Figure 8-2b.** Buxton Creek South of Bell Road

material placed in it. See **Figures 8-2a** and **8-2b** for 1994 aerial imagery where the historic channels are visible.

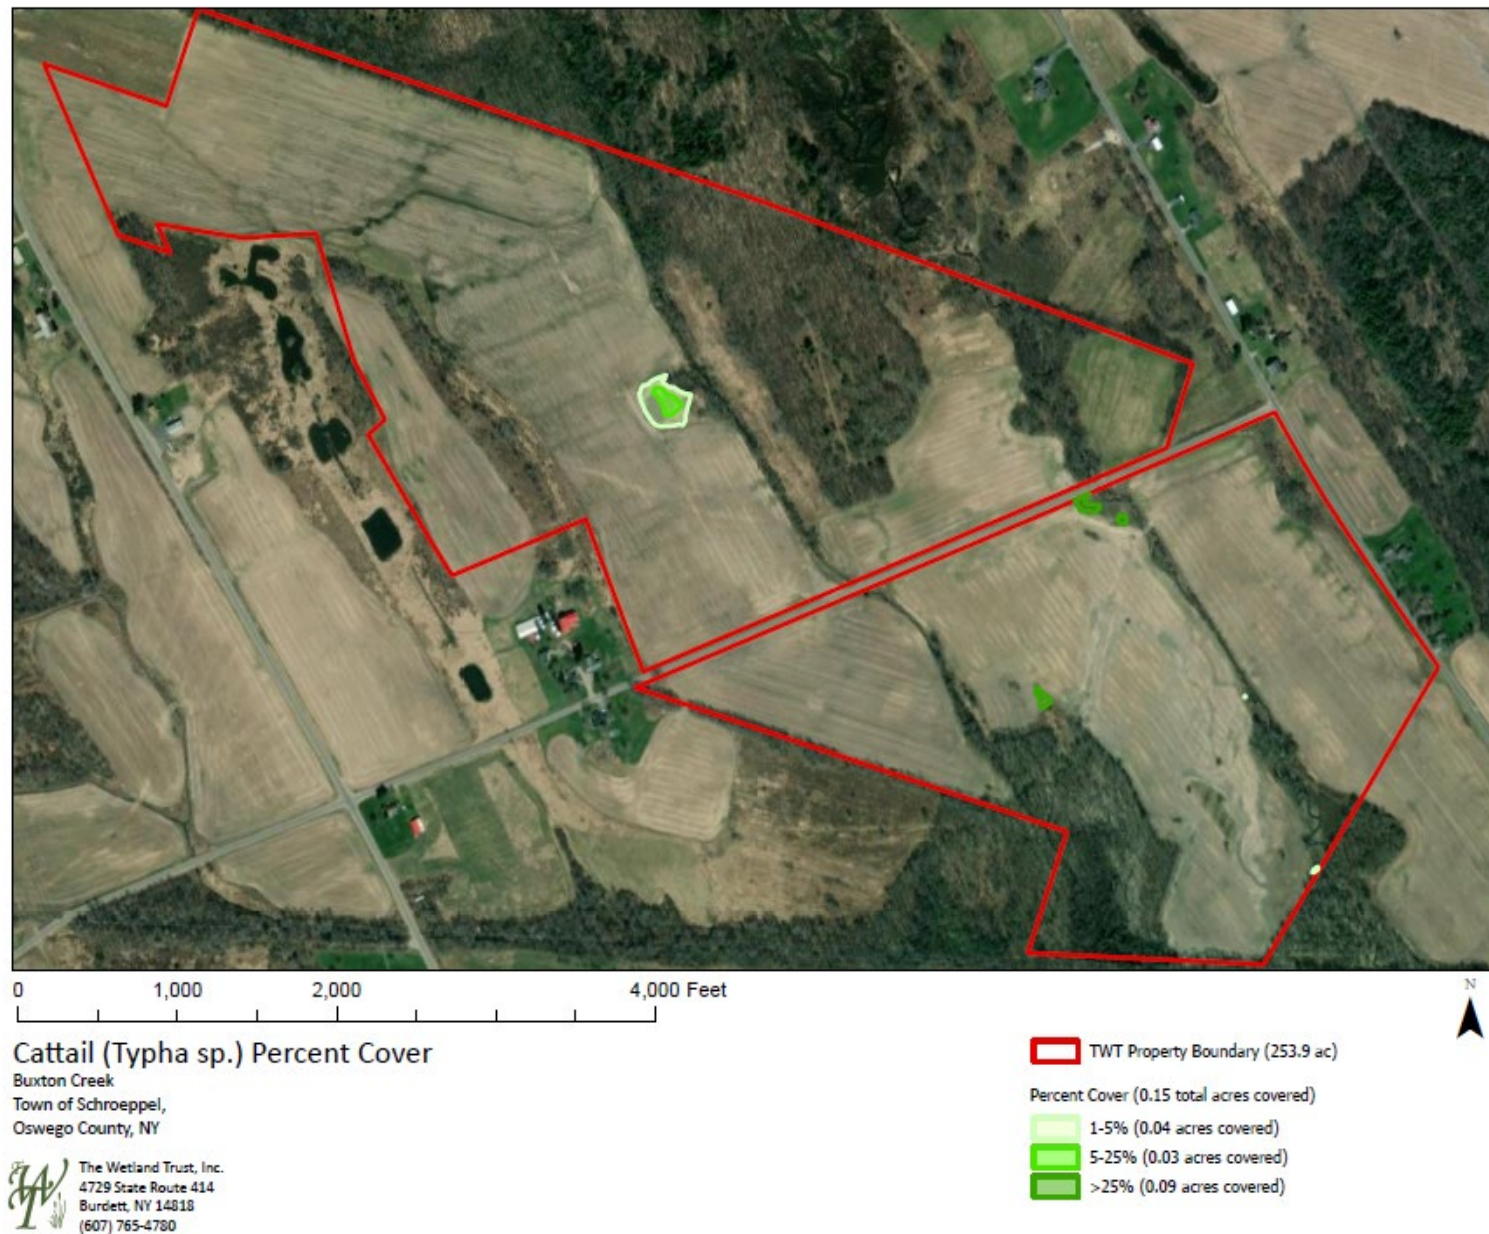
**Figure 8-4** Baseline Cattail Percent Cover (2024)

Baseline data collection will identify existing invasive species communities within the mitigation site. This process will involve field surveys using GIS mapping, orthoimagery using drones, and photographic documentation to establish the extent and density of invasive species populations. Baseline surveys will include mapping of invasive species distribution with percentage cover estimates. The data collected will be used to inform the site preparation and treatment strategies outlined in later sections of this ISMP. See **Figures 8-1 through 8-4** in **Section 8** for baseline invasive species maps.

Key invasive plants include purple loosestrife (*Lythrum salicaria*), reed canary grass (*Phalaris arundinacea*), common reed (*Phragmites australis*), and cattail (*Typha* spp.). These species are highly competitive, forming dense monocultures that outcompete native vegetation, diminish biodiversity, and disrupt wetland functionality. These species cover approximately 7 acres across the site but are largely outside of the wetland work areas. Refer to the Invasive Species Management Plan in **Appendix E** for baseline maps of existing invasive species.

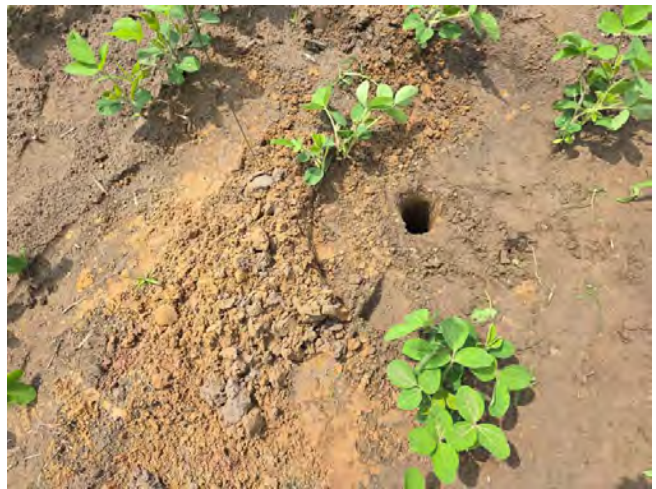
Plant species: Soybeans	How the planned wetland is marked on the ground: Pink wire flags
Invasive species: Chufa (nut sedge)	Groundwater elevation in test hole? 39-inches below the surface.
Hydric soil present near the surface? No	Elevation-change: 2.0-feet
Test Hole location: 43.284620°N 76.232895°W Soil texture: 0-10-inches = silt-loam, 10-25-inches = fine sandy loam, 25-41-inches = silt loam, 41-48-inches = clay loam (2-inch-long thin ribbons). The silt-loam and clay <i>will be needed to build groundwater dams for wetlands where sand is near the surface.</i>	
Rock armoring at inlet and outlet: Not needed	
Head-cuts located uphill or downhill of the planned wetland. None	
Woody debris source: Not available on site. Would need to be transported to the site.	
Construction notes: Dig a core trench and build a groundwater dam around the lower 2/3 perimeter of the area. Excavate a large and shallow basin that is deepest in the center. May need to transport clay from another area to fill the core trench. Spread excess soil in the buffer along the uphill and west edge of the area. Create pits, mounds, and scrapes. Plant trees and shrubs on the mounds.

W-3 (showing test hole)

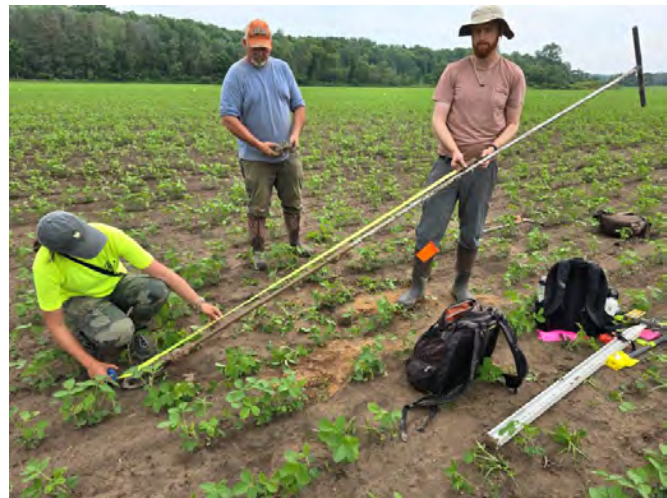
Plant species: Soybeans	How the planned wetland is marked on the ground: Yellow wire flags
Invasive species: Chufa (nut sedge)	Groundwater elevation in test hole? 44-inches below the surface.
Hydric soil present near the surface? No	Elevation-change: 2.0-feet
Test Hole location: 43.288405°N 76.235181°W Soil texture: 0-10-inches = topsoil, 10-44-inches = fine sandy loam, 44-102-inches = clay.	
Rock armoring at inlet and outlet: Not needed	
Head-cuts located uphill or downhill of the planned wetland. None	
Woody debris source: Not available on site. Would need to be transported to the site.	
Construction notes: Block diversion ditch along the west side of the field. Dig a core trench and build a groundwater dam around the lower 2/3 perimeter of the area. Excavate a large and shallow basin that is deepest in the center. Transport clay from another area to fill the core trench. Spread excess soil west of the area. Create pits, mounds, and scrapes. Loosen compacted soil and plant trees and shrubs on the mounds.

W-7 (using a 10.5-foot soil auger to dig the test hole)

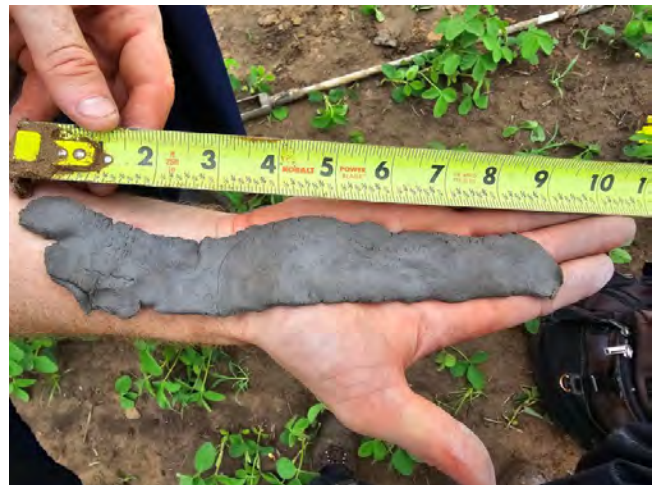
Plant species: Soybeans	How the planned wetland is marked on the ground: White wire flags
Invasive species: Chufa (nut sedge)	Groundwater elevation in test hole? 29-inches below the surface.
Hydric soil present near the surface? No	Elevation-change: 2.0-feet
Test Hole location: 43.288405°N 76.235181°W Soil texture: 0-8-inches = topsoil, 8-29-inches = sandy loam, 29-35-inches = sandy clay, 35-65-inches = clay.	
Rock armoring at inlet and outlet: Not needed	
Head-cuts located uphill or downhill of the planned wetland. None	
Woody debris source: Not available on site. Would need to be transported to the site.	
Construction notes: Dig a core trench and build a groundwater dam around the lower 2/3 perimeter of the area. Excavate a large and shallow basin that is deepest in the center. Transport clay from another area to fill the core trench. Spread excess soil downhill and south of the area. Create pits, mounds, and scrapes. Loosen compacted soil and plant trees and shrubs on the mounds.

W-8 (showing clay that is present 35-inches below the surface)

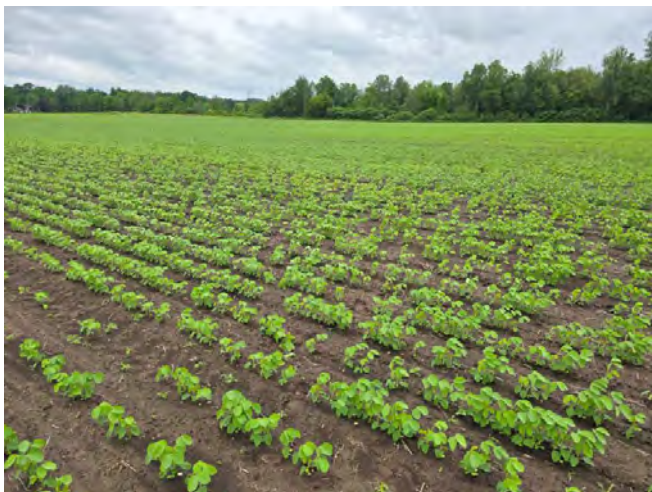
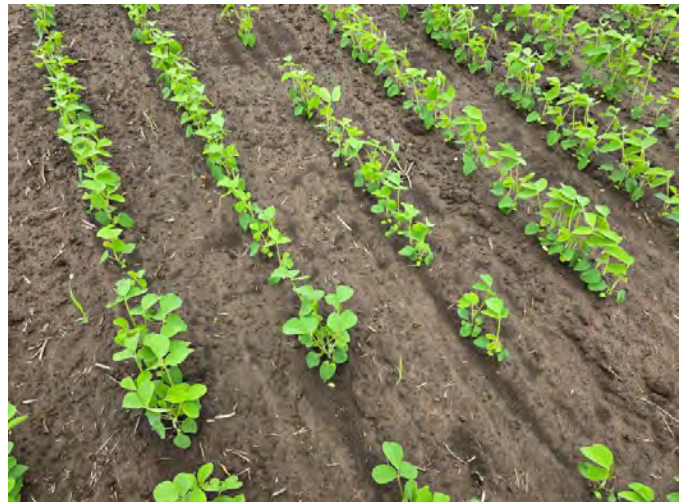
Site Name: W-14 (Bell Road)	Date: 06-24-2024
Landowner: The Wetland Trust	Designer Name: Thomas R. Biebighauser
Individuals assisting with the design: Kirsten Gerhardt (The Wetland Trust)	
Objectives: Build a naturally appearing Forested and Shrub-Scrub for mitigation.	Site Description: An agricultural field that is planted with soybeans.
Evidence of historic drainage or filling: There is a deep diversion ditch located along the west edge of the field, and a deep ditch bordering the east edge of the field. These ditches are drying the valley because they intercept the sand layer near the surface of the fields. The east ditch is deep enough to serve as a main outlet for buried drainage structures. Additional ditches are located around the field edges that are diverting runoff, removing surface water, and lowering the elevation of groundwater. Historic basins have also been filled and the surface of fields sloped for drainage.

Plant species: Soybeans	How the planned wetland is marked on the ground: White wire flags
Invasive species: Chufa (nut sedge)	Groundwater elevation in test hole? 40-inches below the surface.
Hydric soil present near the surface? No	Elevation-change: 2.0-feet
Test Hole location: 43.289755°N 76.239767°W Soil texture: 0-8-inches = topsoil, 8-40-inches = sandy loam, 40-52-inches silt loam, 52-inches += clay	
Rock armoring at inlet and outlet: Not needed.	
Head-cuts located uphill or downhill of the planned wetland. No	
Woody debris source: Not available on site. Would need to be transported to the site.	
Construction notes: Dig a core trench and build a groundwater dam around the lower 2/3 perimeter of the area. Excavate a large and shallow basin that is deepest in the center. Transport clay from another area to fill the core trench, replacing the sandy loam with clay. Spread excess soil south into the buffer. Create pits, mounds, and scrapes. Loosen compacted soil and plant trees and shrubs on the mounds.

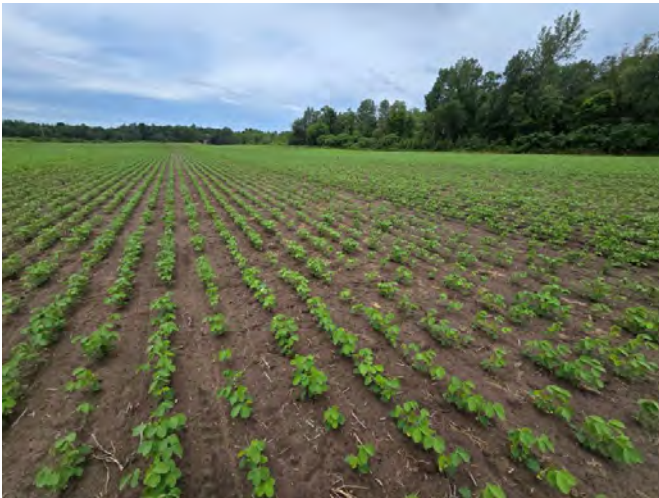
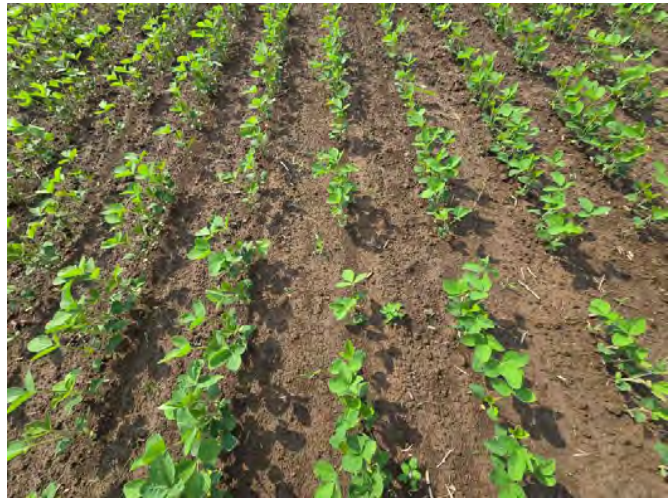
Site Name: W-15 (Bell Road)	Date: 06-24-2024
Landowner: The Wetland Trust	Designer Name: Thomas R. Biebighauser
Individuals assisting with the design: Kirsten Gerhardt (The Wetland Trust)	
Objectives: Build a naturally appearing Forested and Shrub-Scrub for mitigation.	Site Description: An agricultural field that is planted with soybeans.
Evidence of historic drainage or filling: There is a deep diversion ditch located along the west edge of the field, and a deep ditch bordering the east edge of the field. These ditches are drying the valley because they intercept the sand layer near the surface of the fields. The east ditch is deep enough to serve as a main outlet for buried drainage structures. Additional ditches are located around the field edges that are diverting runoff, removing surface water, and lowering the elevation of groundwater. Historic basins have also been filled and the surface of fields sloped for drainage.

Plant species: Soybeans	How the planned wetland is marked on the ground: Pink wire flags
Invasive species: Chufa (nut sedge)	Groundwater elevation in test hole? 20-inches below the surface.
Hydric soil present near the surface? No	Elevation-change: 1.2-feet
Test Hole location: 43.290784°N 76.239625°W Soil texture: 0-9-inches = topsoil, 8-28-inches = sandy silt loam, 44-inches + = clay loam	
Rock armoring at inlet and outlet: Not needed.	
Head-cuts located uphill or downhill of the planned wetland. No	
Woody debris source: Not available on site. Would need to be transported to the site.	
Construction notes: Dig a core trench and build a groundwater dam around the lower 2/3 perimeter of the area. Excavate a large and shallow basin that is deepest in the center. Transport clay from another area to fill the core trench, replacing the sandy loam with clay. Spread excess soil north into the buffer. Create pits, mounds, and scrapes. Loosen compacted soil and plant trees and shrubs on the mounds.

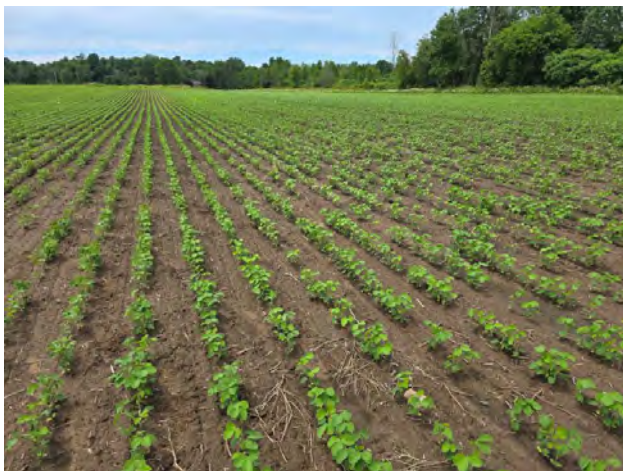
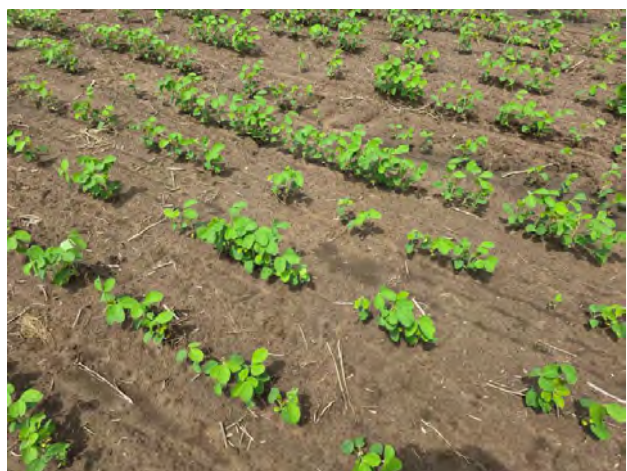
Site Name: W-17 (Bell Road)	Date: 06-24-2024
Landowner: The Wetland Trust	Designer Name: Thomas R. Biebighauser
Individuals assisting with the design: Kirsten Gerhardt (The Wetland Trust)	
Objectives: Build a naturally appearing Forested and Shrub-Scrub for mitigation.	Site Description: An agricultural field that is planted with soybeans.
Evidence of historic drainage or filling: A deep ditch borders the east edge of the field. This ditch is drying the valley because it intercepts the sand layer near the surface of the fields. The ditch is deep enough to serve as a main outlet for buried drainage structures. Additional ditches are located around the field edges that are diverting runoff, removing surface water, and lowering the elevation of groundwater. Historic basins have also been filled and the surface of fields sloped for drainage.	
Plant species: Soybeans	How the planned wetland is marked on the ground: Pink wire flags

Invasive species: Chufa (nut sedge)	Groundwater elevation in test hole? 35-inches below the surface.
Hydric soil present near the surface? No	Elevation-change: 2.0-feet
Test Hole location: 43.289757°N 76.241339°W Soil texture: 0-11-inches = topsoil, 11-55-inches = sandy loam, 55-inches + = clay	
Rock armoring at inlet and outlet: Not needed.	
Head-cuts located uphill or downhill of the planned wetland. No	
Woody debris source: Not available on site. Would need to be transported to the site.	
Construction notes: Dig a core trench and build a groundwater dam around the lower 2/3 perimeter of the area. Excavate a large and shallow basin that is deepest in the center. Transport clay from another area to fill the core trench, replacing the sandy loam with clay. Spread excess soil south. Create pits, mounds, and scrapes. Loosen compacted soil and plant trees and shrubs on the mounds.

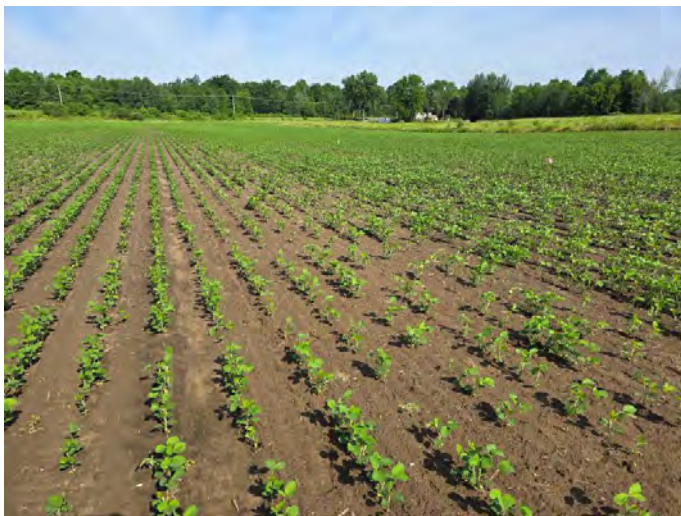
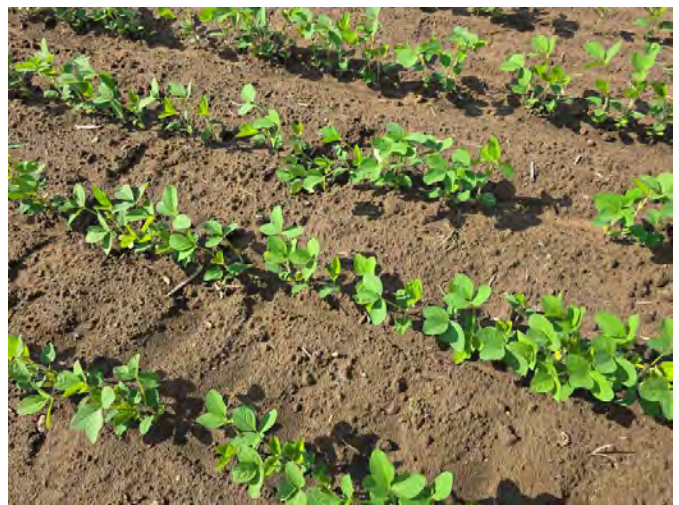
Site Name: W-20 (Bell Road)	Date: 6-25-2024
Landowner: The Wetland Trust	Designer Name: Thomas R. Biebighauser
Individuals assisting with the design: Kirsten Gerhardt (The Wetland Trust), Kendall Hastings (The Wetland Trust)	
Objectives: Build a naturally appearing Forested and Shrub-Scrub for mitigation.	Site Description: An agricultural field that is planted with soybeans.
Evidence of historic drainage or filling: A deep ditch borders the east edge of the field. This ditch is drying the valley because it intercepts the sand layer near the surface of the fields. The ditch is deep enough to serve as a main outlet for buried drainage structures. Additional ditches are located around the field edges that are diverting runoff, removing surface water, and lowering the elevation of groundwater. Historic basins have also been filled and the surface of fields sloped for drainage.	
Plant species: Soybeans	How the planned wetland is marked on the ground: Pink wire flags

Invasive species: Chufa (nut sedge)	Groundwater elevation in test hole? 42-inches below the surface.
Hydric soil present near the surface? No	Elevation-change: 2.6-feet
Test Hole location: 43.290371°N 76.242612°W Soil texture: 0-11 inches = topsoil, 11-74-inches = sandy loam, 74-inches + = clay	
Rock armoring at inlet and outlet: Not needed.	
Head-cuts located uphill or downhill of the planned wetland. No	
Woody debris source: Not available on site. Would need to be transported to the site.	
Construction notes: Dig a core trench and build a groundwater dam around the lower 2/3 perimeter of the area. Excavate a large and shallow basin that is deepest in the center. Transport clay from another area to fill the core trench, replacing the sandy loam with clay. Spread excess soil north. Create pits, mounds, and scrapes. Loosen compacted soil and plant trees and shrubs on the mounds.

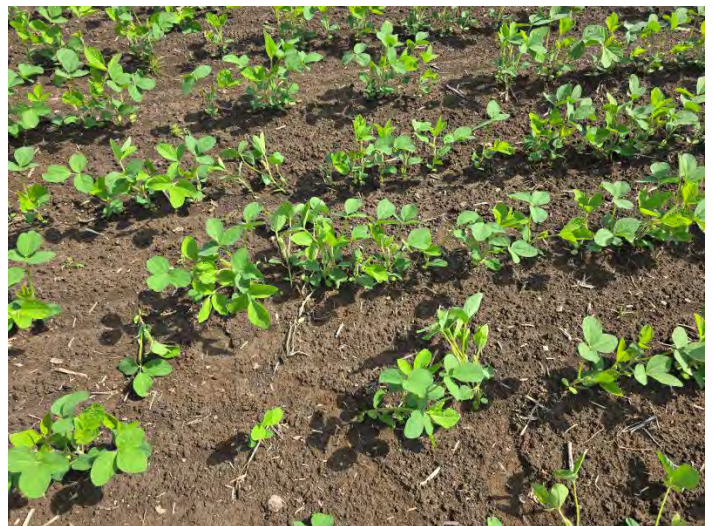
Site Name: W-21 (Bell Road)	Date: 6-25-2024
Landowner: The Wetland Trust	Designer Name: Thomas R. Biebighauser
Individuals assisting with the design: Kirsten Gerhardt (The Wetland Trust), Kendall Hastings (The Wetland Trust), Dylan Johnson-Jordan	
Objectives: Build a naturally appearing Forested and Shrub-Scrub for mitigation.	Site Description: An agricultural field that is planted with soybeans.
Evidence of historic drainage or filling: A deep ditch borders the east edge of the field. This ditch is drying the valley because it intercepts the sand layer near the surface of the fields. The ditch is deep enough to serve as a main outlet for buried drainage structures. Additional ditches are located around the field edges that are diverting runoff, removing surface water, and lowering the elevation of groundwater. Historic basins have also been filled and the surface of fields sloped for drainage.

Plant species: Soybeans	How the planned wetland is marked on the ground: White wire flags
Invasive species: Chufa (nut sedge)	Groundwater elevation in test hole? 38-inches below the surface.
Hydric soil present near the surface? No	Elevation-change: 2.0-feet
Test Hole location: 43.2905881°N 76.243586°W Soil texture: 0-10 inches = topsoil, 10-48-inches = sandy loam, clay may be 70-inches deep.	
Rock armoring at inlet and outlet: Not needed.	
Head-cuts located uphill or downhill of the planned wetland. No	
Woody debris source: Not available on site. Would need to be transported to the site.	
Construction notes: Dig a core trench and build a groundwater dam around the lower 2/3 perimeter of the area. Excavate a large and shallow basin that is deepest in the center. Transport clay from another area to fill the core trench, replacing the sandy loam with clay. Spread excess soil north or west. Create pits, mounds, and scrapes. Loosen compacted soil and plant trees and shrubs on the mounds.

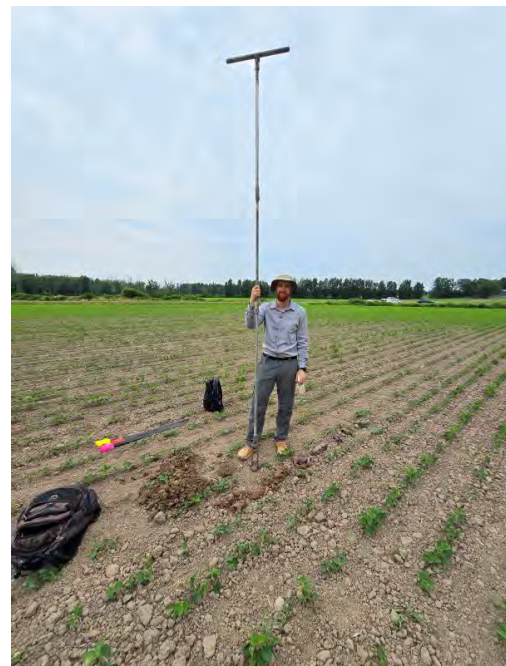
Reed 1 (digging a deep test hole using a 10.5-foot-long soil auger)

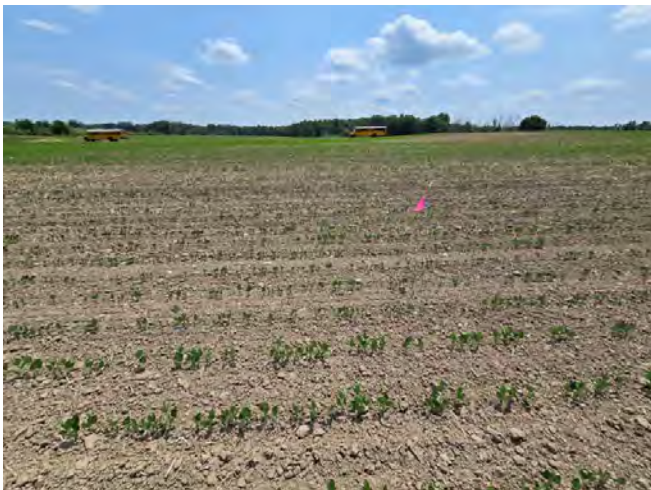
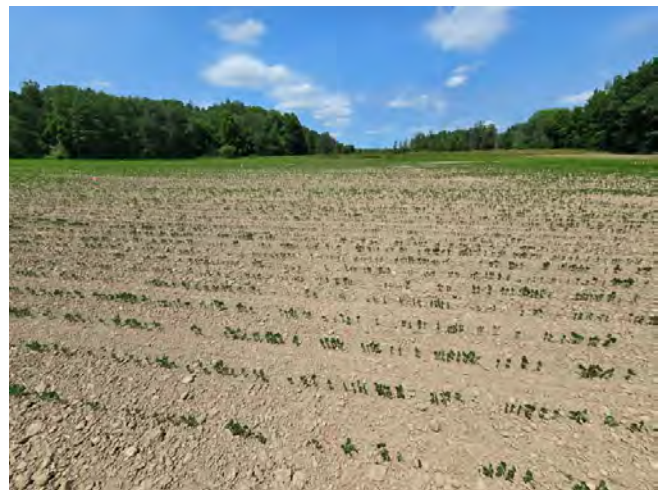
Site Name: Reed 3	Date: 06-21-2024
Landowner: The Wetland Trust	Designer Name: Thomas R. Biebighauser
The Wetland Trust Employees assisting with the design: Kendall Hastings, Dylan Johnston-Jordan	
Objectives: Build a naturally appearing and functioning wetland for mitigation.	Site Description: An agricultural field planted to soybeans.
Evidence of historic drainage or filling: Ditches border all sides of the field. The deep ditch along the west side and along Bell Road may serve as outlets for buried drainage systems. Natural basins have been filled and the land sloped for drainage.	
Plant species: Planted soybeans	How the planned wetland is marked on the ground: Pink wire flags
Invasive species: Reed Canary grass on neighboring private land.	Groundwater elevation in test hole? Not detected
Hydric soil present near the surface? No	Elevation-change upper to lower edge of designed wetland: 2.0-feet

Test Hole location: 43.287174°N 76.228208°W Soil texture: 0-7-inches = topsoil, 7-29-inches = clay, 29-34-inches = mixed clay and gravel, 34-48-inches = clay\	
Rock armor the inlet and outlet for the wetland? Not needed.	
Head-cuts located uphill or downhill of the planned wetland. None.	
Woody debris source: Not available on site. Would need to be brought in by truck.	
Construction notes: Build a groundwater dam along the lower perimeter of the wetland being built. Build an above ground dam that is no higher than 12-inches. Spread soil downhill. Add pits, scrapes, and mounds and then plant with native trees and shrubs.

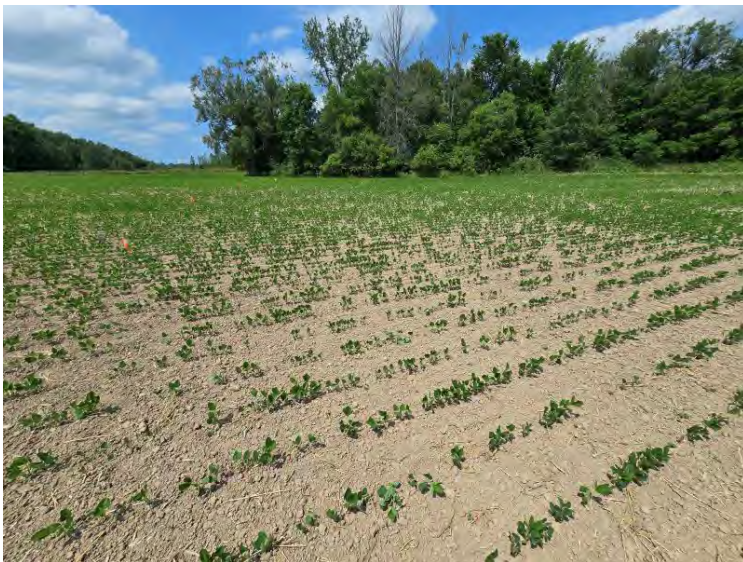
Site Name: Reed 4	Date: 06-21-2024
Landowner: The Wetland Trust	Designer Name: Thomas R. Biebighauser
The Wetland Trust Employees assisting with the design: Kendall Hastings, Dylan Johnston-Jordan	
Objectives: Build a naturally appearing and functioning wetland for mitigation.	Site Description: An agricultural field planted to soybeans.
Evidence of historic drainage or filling: Ditches border all sides of the field. The deep ditch along the west side and along Bell Road may serve as outlets for buried drainage systems. Natural basins have been filled and the land sloped for drainage.	
Plant species: Planted soybeans	How the planned wetland is marked on the ground: Orange wire flags
Invasive species: Reed Canary grass on neighboring private land.	Groundwater elevation in test hole? 43-inches below surface
Hydric soil present near the surface? No	Elevation-change upper to lower edge of designed wetland: 2.0-feet

Test Hole location: 43.286521°N 76.227220°W Soil texture: 0-9-inches = topsoil, 9-38-inches = clay, 38-54-inches = sandy loam, 54-inches + = clay	
Rock armor the inlet and outlet for the wetland? Not needed.	
Head-cuts located uphill or downhill of the planned wetland. None.	
Woody debris source: Not available on site. Would need to be brought in by truck.	
Construction notes: Build a groundwater dam along the lower perimeter of the wetland being built. Build an above ground dam that is no higher than 12-inches. Spread soil downhill and into buffer along the Bell Road. Add pits, scrapes, and mounds and then plant with native trees and shrubs. Place sandy loam soil for turtle nesting habitat.

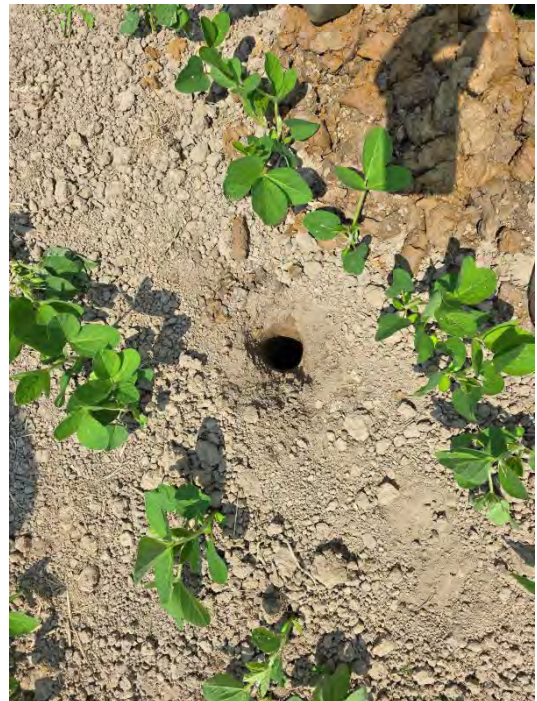
Reed 4 (showing soil test hole)

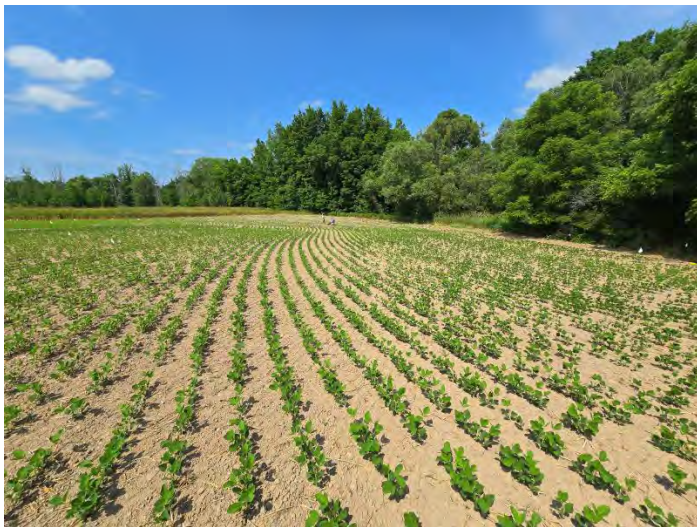
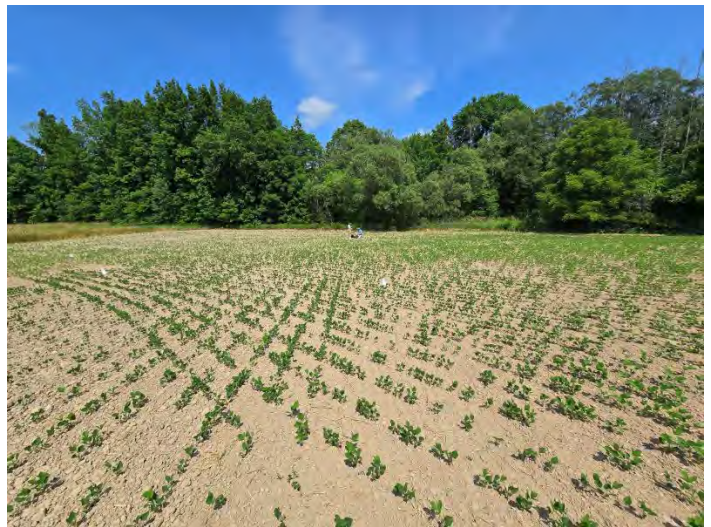
Site Name: Reed 5	Date: 06-21-2024
Landowner: The Wetland Trust	Designer Name: Thomas R. Biebighauser
The Wetland Trust Employees assisting with the design: Kendall Hastings, Dylan Johnston-Jordan	
Objectives: Build a naturally appearing and functioning wetland for mitigation.	Site Description: An agricultural field planted to soybeans.
Evidence of historic drainage or filling: Ditches border all sides of the field. The deep ditch along the west side and along Bell Road may serve as outlets for buried drainage systems. Natural basins have been filled and the land sloped for drainage.	
Plant species: Planted soybeans	How the planned wetland is marked on the ground: White wire flags
Invasive species: Reed Canary grass on neighboring private land.	Groundwater elevation in test hole? Not detected.
Hydric soil present near the surface? No	Elevation-change upper to lower edge of designed wetland: 3.0-feet

Test Hole location: 43.287447°N 76.227815°W Soil texture: 0-8-inches = topsoil, 8-16-inches = clay, 16-37-inches = sandy clay, 37-inches + = clay	
Rock armor the inlet and outlet for the wetland? Not needed.	
Head-cuts located uphill or downhill of the planned wetland. None.	
Woody debris source: Not available on site. Would need to be brought in by truck.	
Construction notes: Build a groundwater dam along the lower perimeter of the wetland being built. Build an above ground dam that is no higher than 16-inches. Spread soil downhill. Add pits, scrapes, and mounds and then plant with native trees and shrubs.

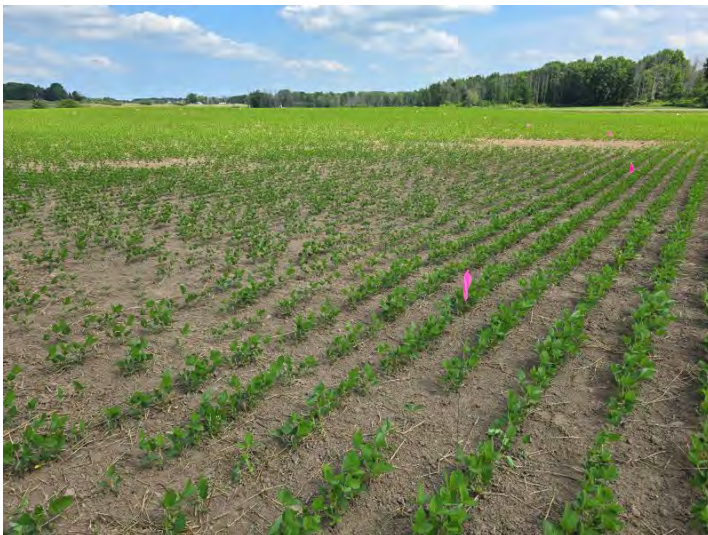
Site Name: Reed 6	Date: 06-21-2024
Landowner: The Wetland Trust	Designer Name: Thomas R. Biebighauser
Objectives: Build a naturally appearing and functioning wetland for mitigation.	Site Description: An agricultural field planted to soybeans.
Evidence of historic drainage or filling: Ditches border all sides of the field. The deep ditch along the west side and along Bell Road may serve as outlets for buried drainage systems. Natural basins have been filled and the land sloped for drainage.	
Plant species: Planted soybeans	How the planned wetland is marked on the ground: Pink wire flags
Invasive species: None	Groundwater elevation in test hole? Not detected.
Hydric soil present near the surface? No	Elevation-change upper to lower edge of designed wetland: 1.8-feet
Test Hole location: 43.286121°N 76.229175°W Soil texture: 0-9-inches = topsoil, 9-48-inches = clay	
Rock armor the inlet and outlet for the wetland? Not needed.

Head-cuts located uphill or downhill of the planned wetland. None.	
Woody debris source: Not available on site. Would need to be brought in by truck.	
Construction notes: Build a groundwater dam along the lower perimeter of the wetland being built. Build an above ground dam that is no higher than 12-inches. Spread soil downhill. Add pits, scrapes, and mounds and then plant with native trees and shrubs.

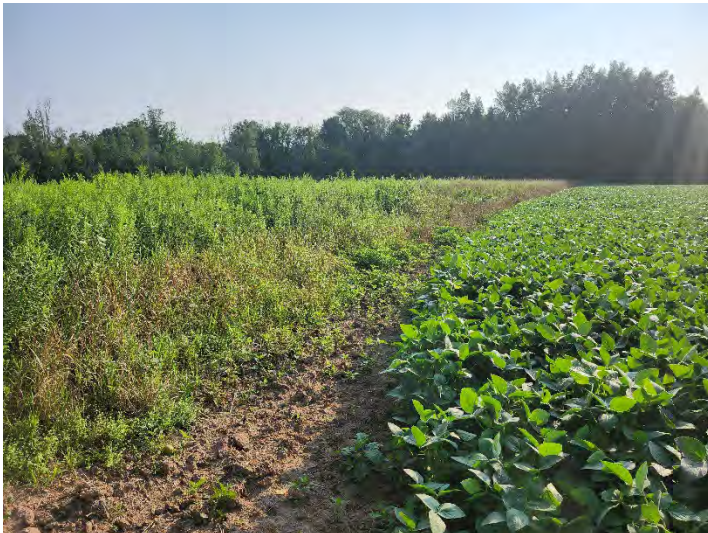
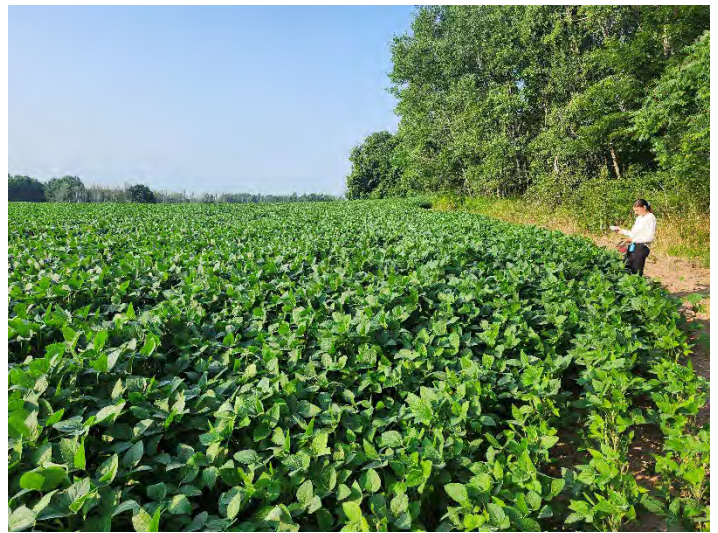
Site Name: Reed 7	Date: 08-01-2024
Landowner: The Wetland Trust	Designer Name: Thomas R. Biebighauser. Assisting: Dylan Johnston-Jordan, Kendall Hastings
Objectives: Build a naturally appearing and functioning wetland for mitigation.	Site Description: An agricultural field planted to soybeans.
Evidence of historic drainage or filling: Deep ditch/creek (Buxton Creek) to the west. The deep ditch Bell Road may serve as outlets for buried drainage systems. Natural basins have been filled and the land sloped for drainage.	
Plant species: Planted soybeans	How the planned wetland is marked on the ground: Not marked
Invasive species: Phalaris arundinacea	Groundwater elevation in test hole? Not detected.
Hydric soil present near the surface? No	Elevation-change upper to lower edge of designed wetland: 2.5-feet
Test Hole location: 43.287359°N 76.229093°W	
Soil texture: 0-20-inches = topsoil silt loam, 20-32-inches = sandy loam, 32-36-inches = clay, 36-45-inches = silt loam

Rock armor the inlet and outlet for the wetland? Not needed.	
Head-cuts located uphill or downhill of the planned wetland. None.	
Woody debris source: Not available on site. Would need to be brought in by truck.	
Construction notes: Build a groundwater dam along the lower perimeter of the wetland being built. Build an above ground dam that is no higher than 12-inches. Spread soil downhill. Add pits, scrapes, and mounds and then plant with native trees and shrubs.

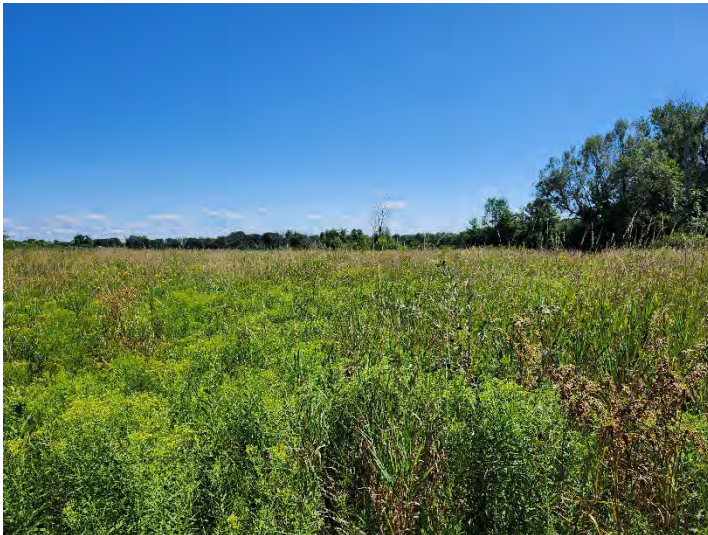
Site Name: Reed 9	Date: 08-01-2024
Landowner: The Wetland Trust	Designer Name: Thomas R. Biebighauser. Assisting: Dylan Johnston-Jordan, Kendall Hastings
Objectives: Build a naturally appearing and functioning wetland for mitigation.	Site Description: Historically farmed field in hay, Buxton creek to the west of the field. Ditch is present along Bell Rd.
Evidence of historic drainage or filling: Deep ditch/creek (Buxton Creek) to the west. The deep ditch Bell Road may serve as outlets for buried drainage systems. Natural basins have been filled and the land sloped for drainage.	
Plant species: Green ash, Purple Stem, Foxtail, Juncus effusus, Grass leaf aster, Salix sp.	How the planned wetland is marked on the ground: Not marked
Invasive species: Phalaris arundinacea, Lythrum salicaria	Groundwater elevation in test hole? Not detected.
Hydric soil present near the surface? Yes	Elevation-change upper to lower edge of designed wetland: 2-feet

Test Hole location: 43.287139°N 76.226299°W Soil texture: 0-10-inches = topsoil clay loam, 10-25-inches = silt clay, 25-34-inches = silt loam, 34-45-inches = silt loam	
Rock armor the inlet and outlet for the wetland? Not needed.	
Head-cuts located uphill or downhill of the planned wetland. None.	
Woody debris source: Not available on site. Would need to be brought in by truck.	
Construction notes: : Status of land for building needs to be determined. Build a groundwater dam along the lower perimeter of the wetland being built. Build an above ground dam that is no higher than 12-inches. Spread soil uphill. Add pits, scrapes, and mounds and then plant with native trees and shrubs.

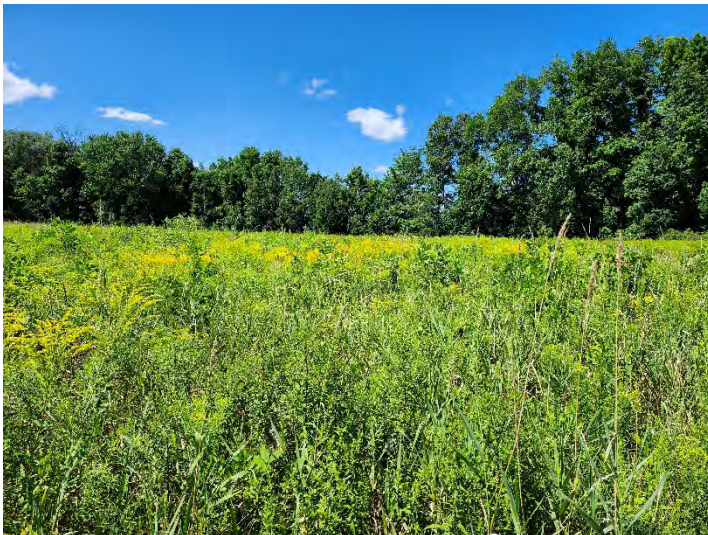
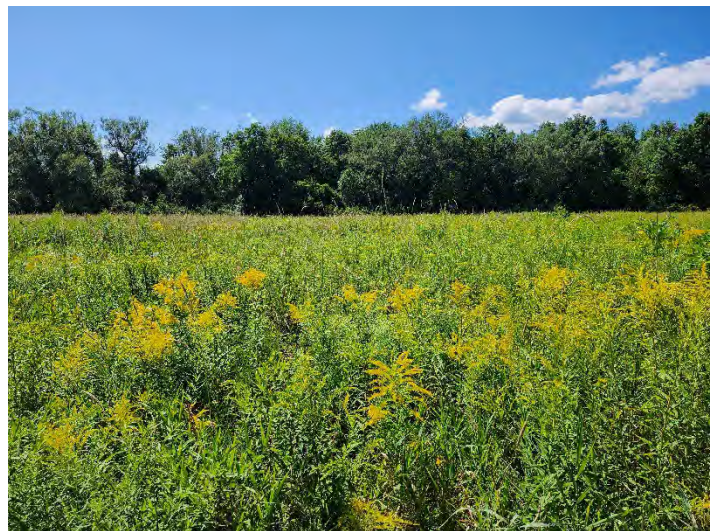
<b>Site Name:</b> Reed 10	<b>Date:</b> 08-01-2024
<b>Landowner:</b> The Wetland Trust	<b>Designer Name:</b> Thomas R. Biebighauser. <b>Assisting:</b> Dylan Johnston-Jordan, Kendall Hastings
<b>Objectives:</b> Build a naturally appearing and functioning wetland for mitigation.	<b>Site Description:</b> Historically farmed field in hay, Buxton creek to the west of the field. Ditch is present along Bell Rd. Reed 10 is east of Reed 9
<b>Evidence of historic drainage or filling:</b> Deep ditch/creek (Buxton Creek) to the west. The deep ditch Bell Road may serve as outlets for buried drainage systems. Natural basins have been filled and the land sloped for drainage.	
<b>Plant species:</b> Green ash, Purple Stem, Foxtail, Juncus effusus, Grass leaf aster, Salix sp.	<b>How the planned wetland is marked on the ground:</b> Not marked
<b>Invasive species:</b> Phalaris arundinacea, Lythrum salicaria	<b>Groundwater elevation in test hole?</b> Not detected.

<b>Hydric soil present near the surface?</b> No	<b>Elevation-change upper to lower edge of designed wetland:</b> 2-feet
<b>Test Hole location:</b> 43.287272°N 76.225547°W <b>Soil texture:</b> 0-12-inches = topsoil silt loam, 12-15-inches = silt loam, 15-40-inches = clay.	
<b>Rock armor the inlet and outlet for the wetland?</b> Rock armor required for spillway due to slope greater than 1 degree	
<b>Head-cuts located uphill or downhill of the planned wetland.</b> None.	
<b>Woody debris source:</b> Not available on site. Would need to be brought in by truck.	
<b>Construction notes:</b> : Status of land for building needs to be determined. Build a groundwater dam along the lower perimeter of the wetland being built. Build an above ground dam that is no higher than 12-inches. Spread soil uphill. Add pits, scrapes, and mounds and then plant with native trees and shrubs.
