# **Micron Central New York Semiconductor Manufacturing Complex**

## **Buxton Creek Stream and Wetland Mitigation Plan**

**Oswego County, NY**

**May 2025**

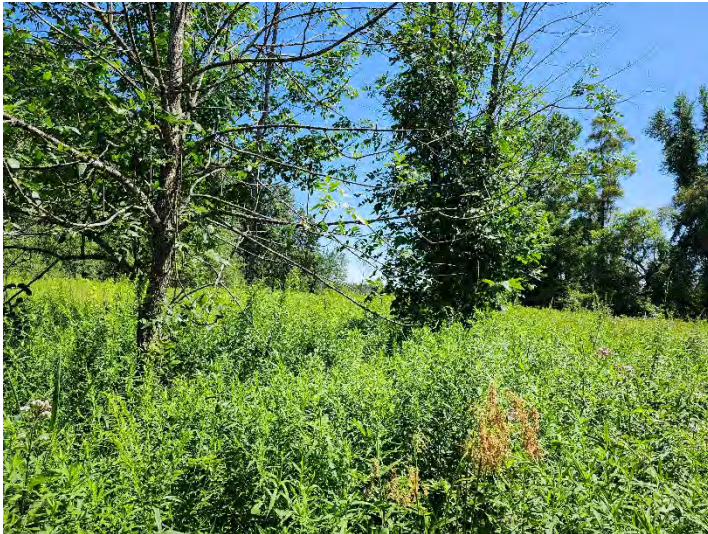
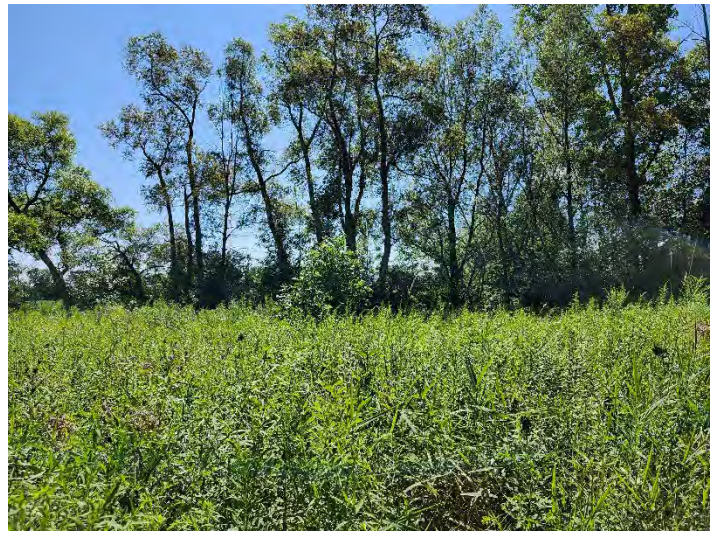
Reed 11

<b>Site Name: Reed 11</b>	<b>Date: 08-01-2024</b>
<b>Landowner: The Wetland Trust</b>	<b>Designer Name: Thomas R. Biebighauser. Assisting: Dylan Johnston-Jordan, Kendall Hastings</b>
<b>Objectives: Build a naturally appearing and functioning wetland for mitigation.</b>	<b>Site Description: Historically farmed field in hay, deep agricultural ditch to the west of the field.</b>
<b>Evidence of historic drainage or filling: Deep agricultural ditch to the west of the field. Natural basins have been filled and the land sloped for drainage. Likely buried drainage structures present.</b>	
<b>Plant species: Onoclea sensibilis, Eutrochium maculatum, Salidago sp., Impatiens compensis</b>	<b>How the planned wetland is marked on the ground: Not marked</b>
<b>Invasive species: Phalaris arundinacea</b>	<b>Groundwater elevation in test hole? Not detected.</b>
<b>Hydric soil present near the surface? No</b>	<b>Elevation-change upper to lower edge of designed wetland: 2-feet</b>

<b>Test Hole location: 43.287348°N 76.232472°W</b>	
<b>Soil texture: 0-8-inches = topsoil silt loam, 8-45-inches = silt loam.</b>	
<b>Rock armor the inlet and outlet for the wetland? Not required</b>	
<b>Head-cuts located uphill or downhill of the planned wetland. None.</b>	
<b>Woody debris source: Not available on site. Would need to be brought in by truck.</b>	
<b>Construction notes: Status of land for building needs to be determined. Build a groundwater dam along the lower perimeter of the wetland being built. Build an above ground dam that is no higher than 12-inches. Spread soil uphill. Add pits, scrapes, and mounds and then plant with native trees and shrubs.</b>

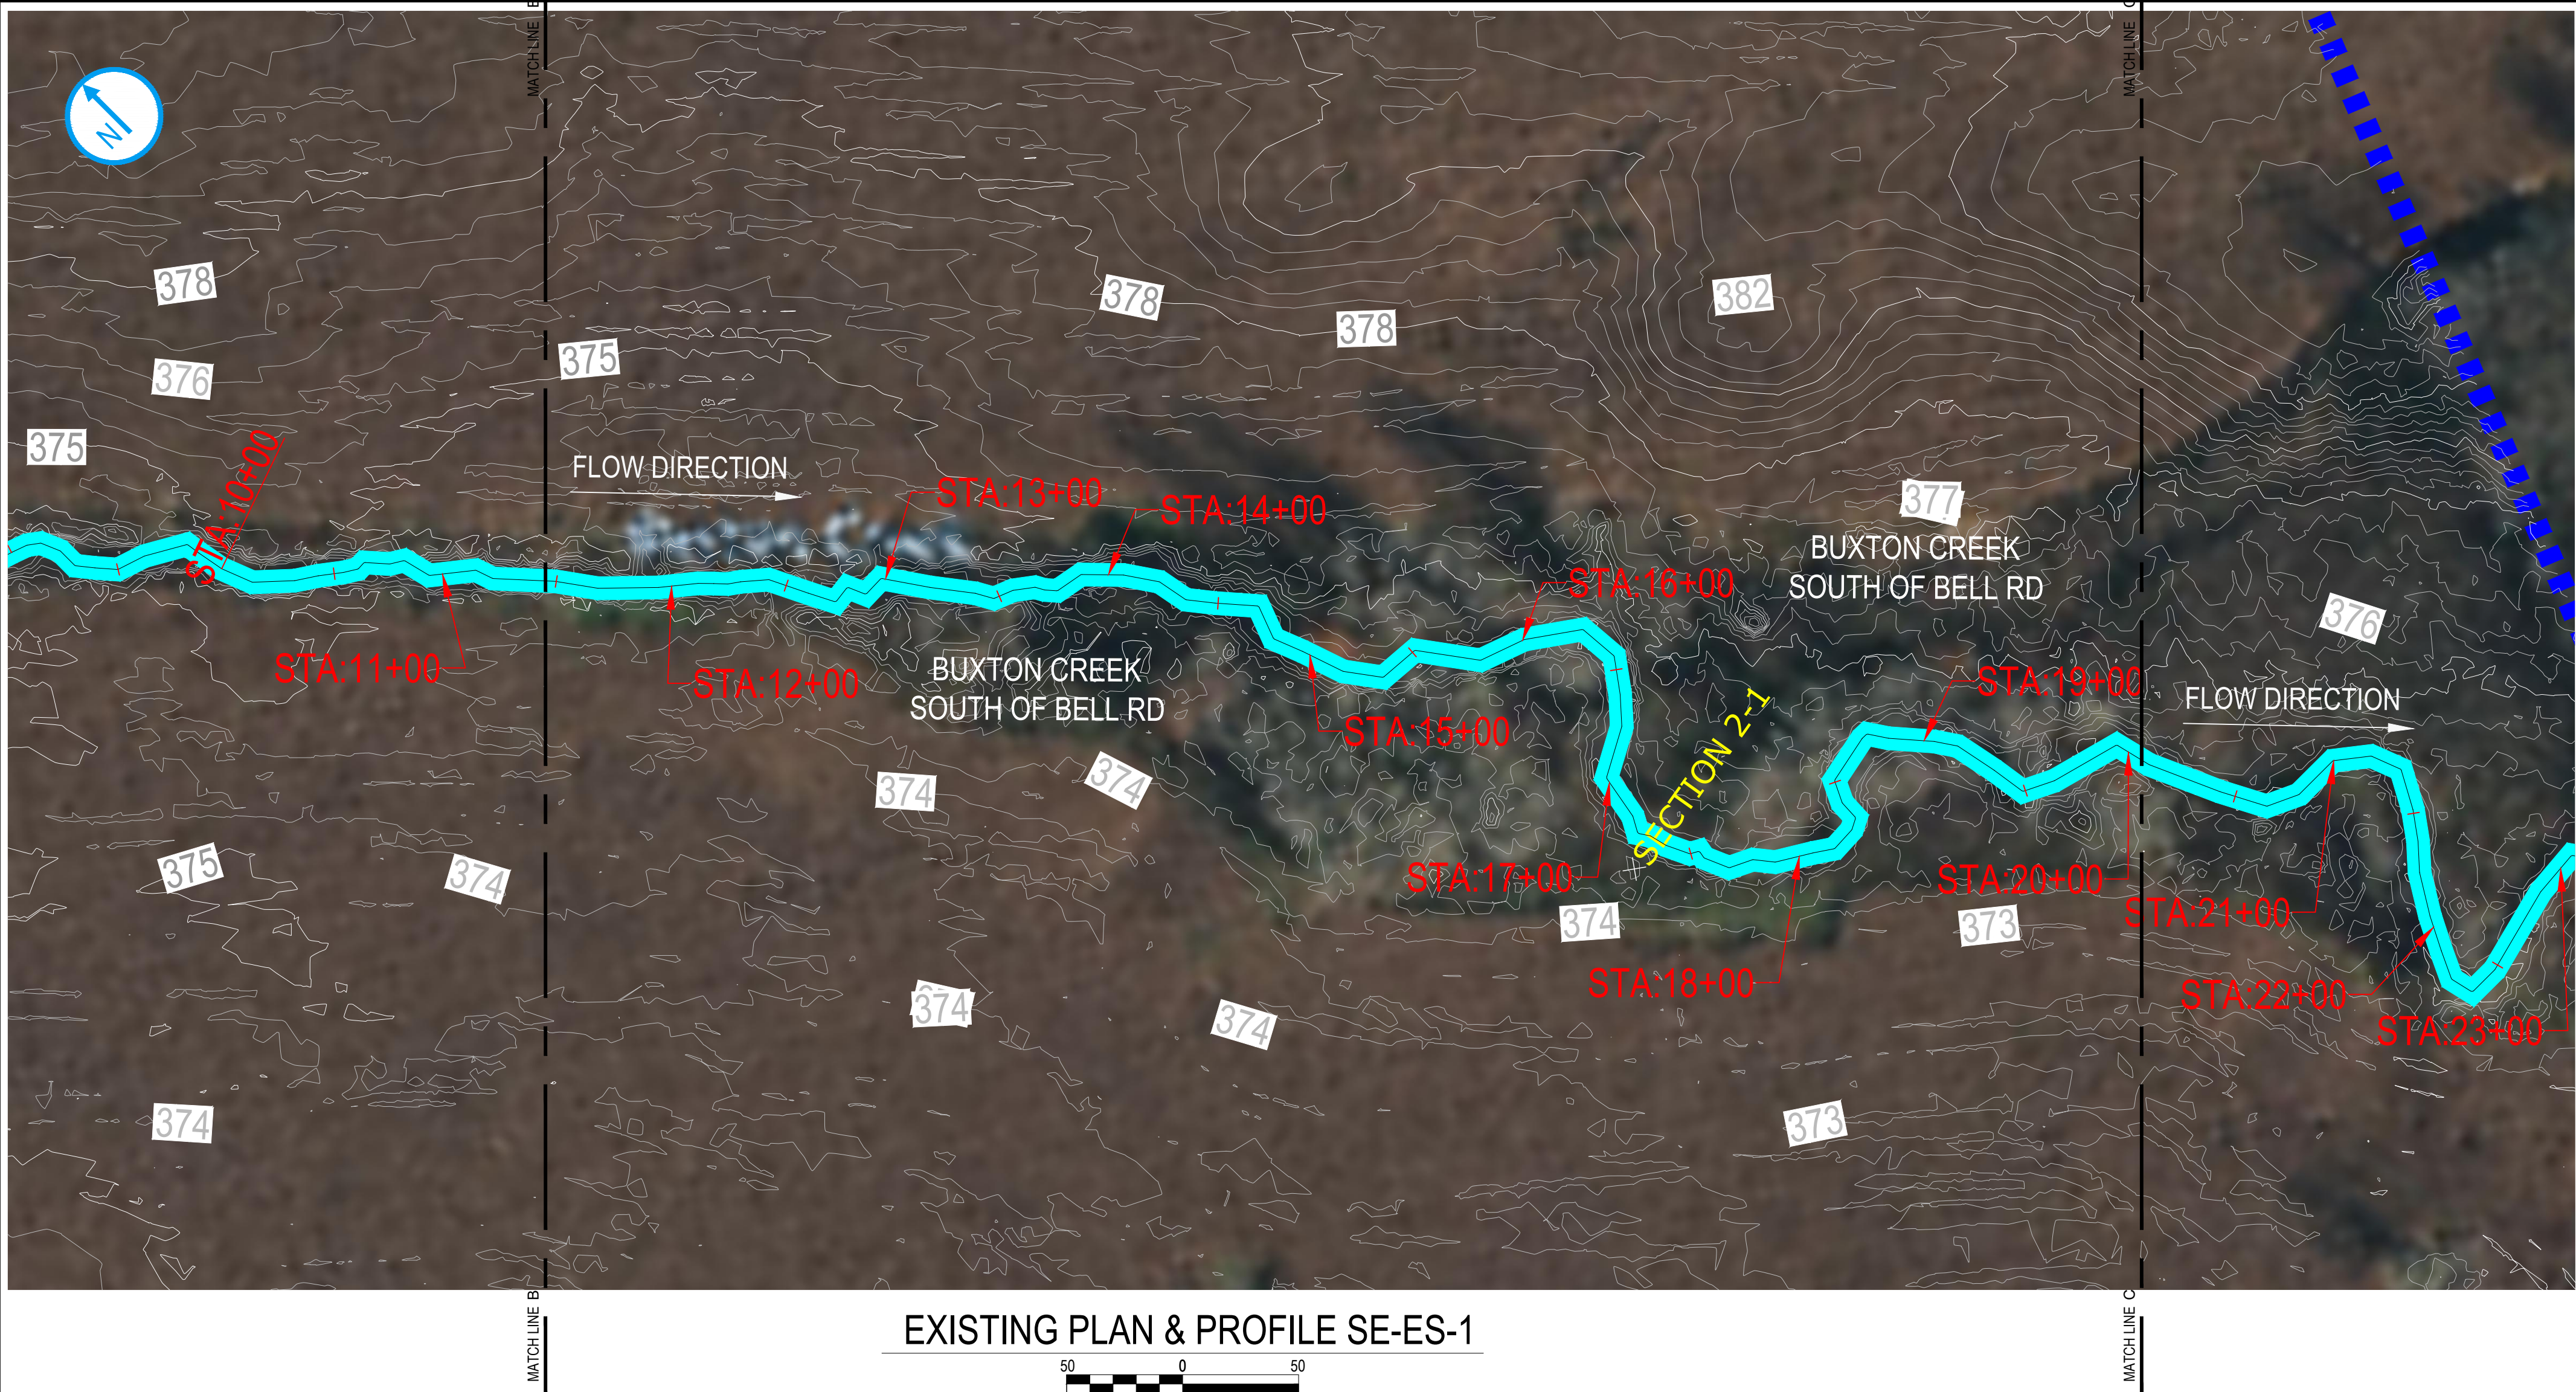
Point Table				
Point #	Elevation (FT)	Northing	Easting	Description
1	373.65	1197435.98	915479.83	SECTION 1-1
2	374.65	1197402.68	915537.78	SECTION 1-2
3	374.58	1196380.77	916083.78	SECTION 2-1
4	374.89	1197976.36	915040.04	SECTION 3-1

\*DISTANCE IS MEASURED FROM NEAR BANK: GREATEST DISTANCE IS STREAM WIDTH.  
\*\*VELOCITY MEASUREMENTS AT 60% OF MAXIMUM STREAM DEPTH.  
STREAM WIDTH = 7.3 FT AT LOCATION OF MEASUREMENTS  
LOCATION : NORTH OF BELL RD  
MEASUREMENT DATE: 11/13/2024
