# Micron Central New York Semiconductor Manufacturing Complex

# **Buxton Creek Stream and Wetland Mitigation Plan**

Oswego County, NY

May 2025

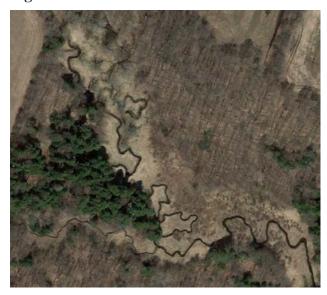
Figure 8-1d. Reference Reach #3 Bell Creek

Imagery: 2017, Location: 43.334094 -76.356244

Local streams that have not been relocated, channelized, placed underground, affected by head cuts, or otherwise heavily altered were used to inform the design of the mitigation streams. Key reference streams were portions of Fish Creek, Bell Creek, and Sixmile Creek as shown in **Figures 8-1a-e.** Reference reach #1 (**Figure 8-1b**) is most proximate to the Buxton Creek property to the northwest. The imagery shows a stream that is braided with a complex of wetlands on nearly level ground. Bell Creek and Sixmile Creek references reaches #2-4 (**Figures 8-1c-e**) exemplify the sinuosity and presence of wetlands on the floodplain of natural streams in the area.

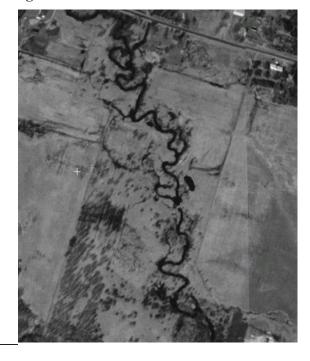
Figure 8-1e. Reference Reach #4 Sixmile Creek

Imagery: 1994, Location: 43.311918, -76.310130

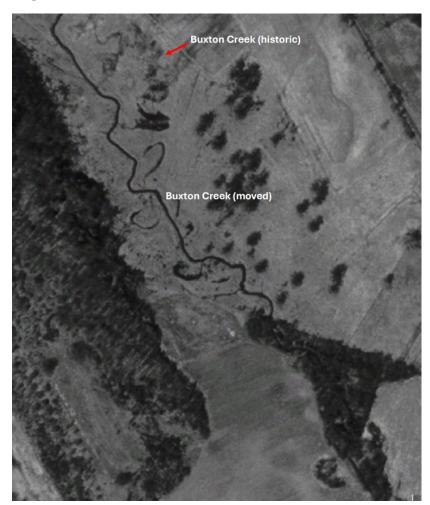
Figure 8-2a. Buxton Creek North of Bell Road

material placed in it. See **Figures 8-2a** and **8-2b** for 1994 aerial imagery where the historic channels are visible.

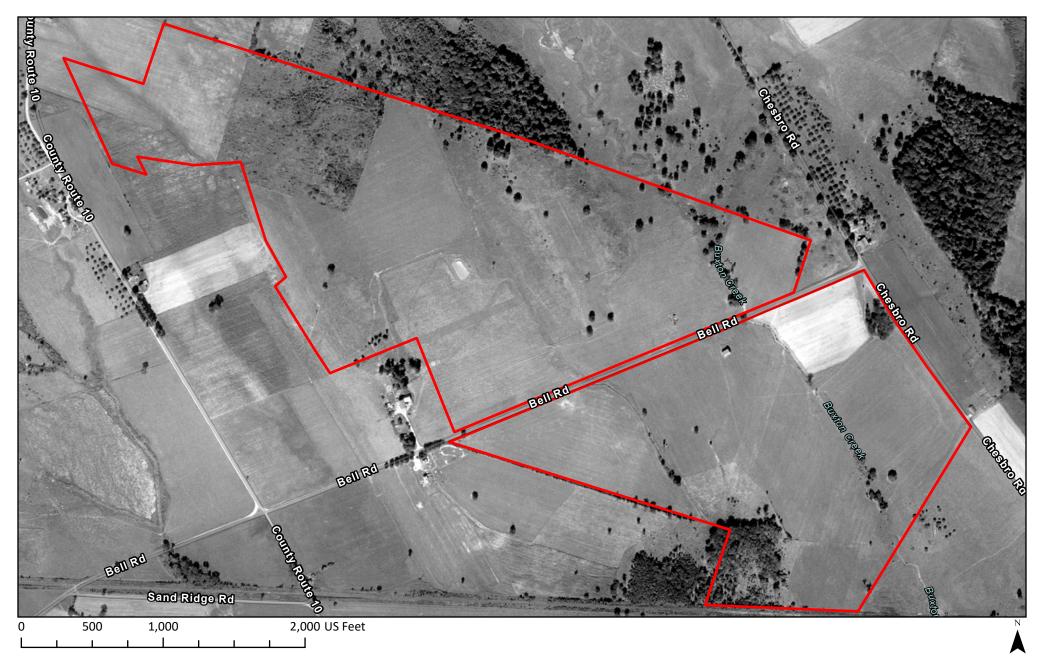
Figure: Imagery (1955)
Buxton Creek
Town of Schroeppel,
Oswego County, NY

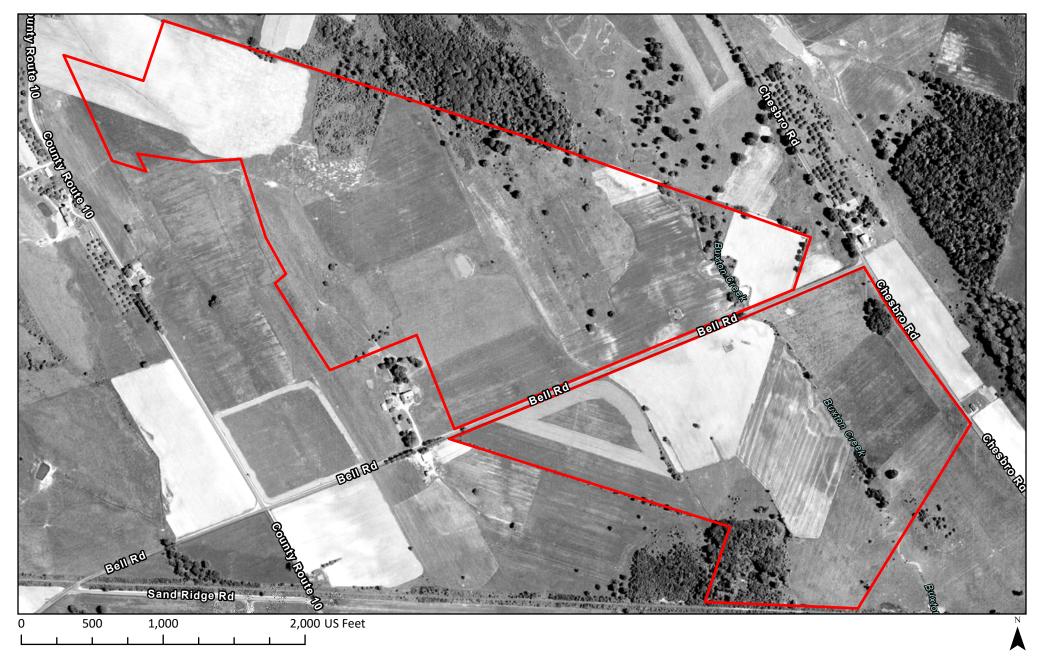
Figure: Imagery (1959)
Buxton Creek
Town of Schroeppel,
Oswego County, NY

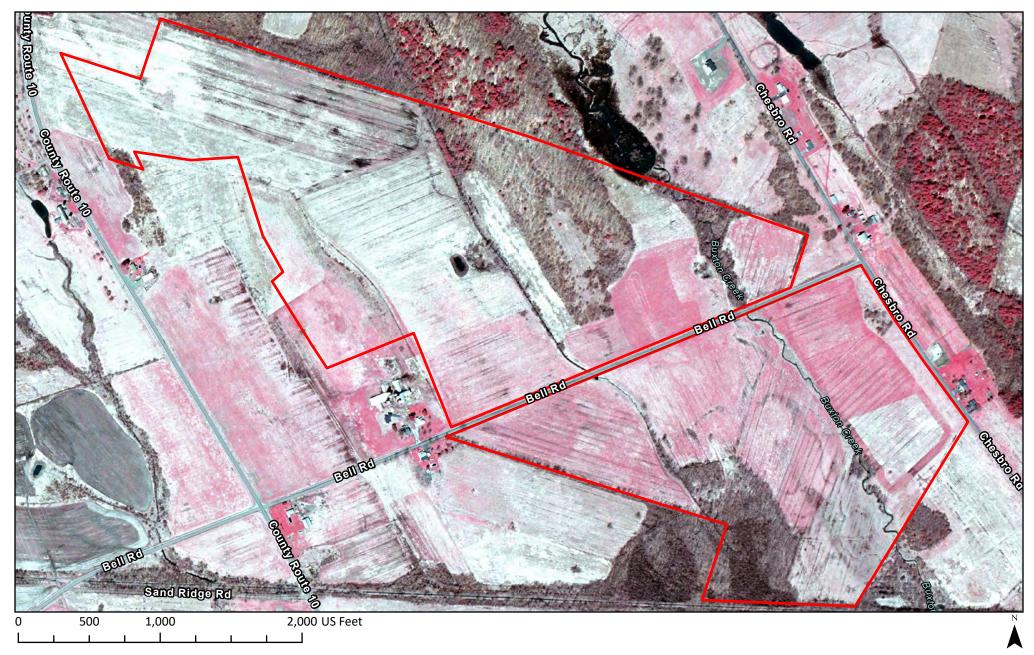
Figure: Imagery (2003)
Buxton Creek
Town of Schroeppel,
Oswego County, NY

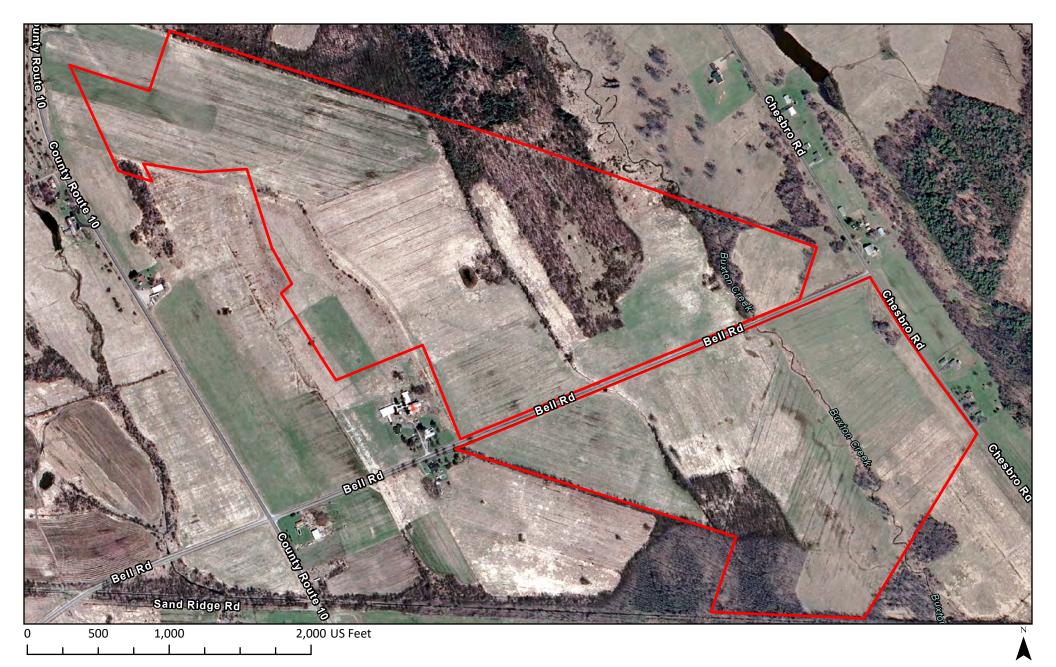
Figure: Imagery (2006)
Buxton Creek
Town of Schroeppel,
Oswego County, NY

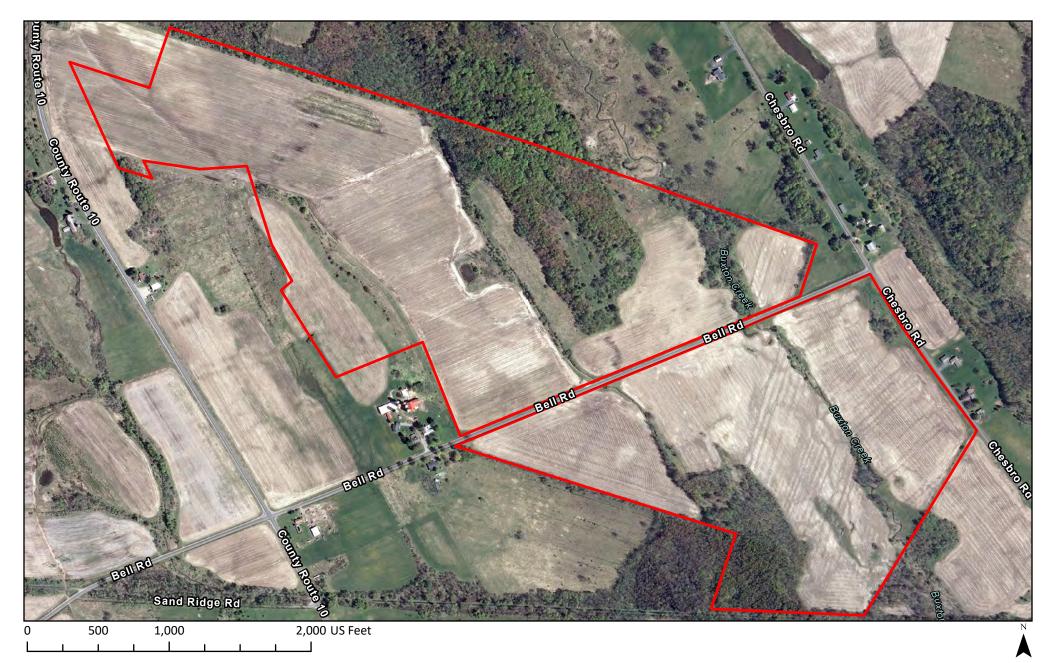
Figure: Imagery (2011)
Buxton Creek
Town of Schroeppel,
Oswego County, NY

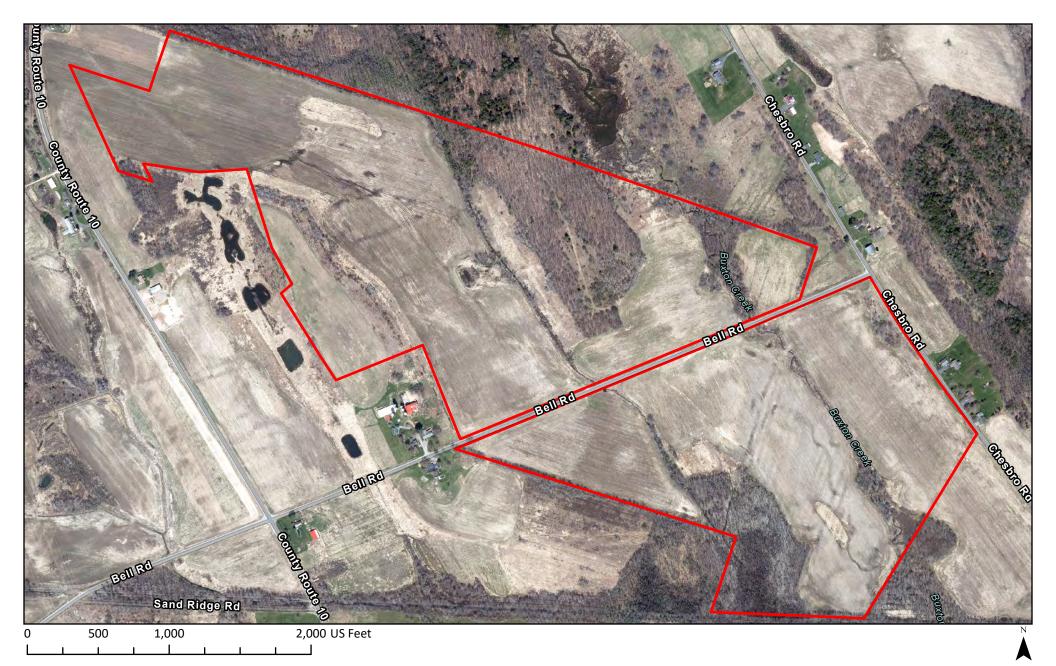
Figure: Imagery (2020)
Buxton Creek
Town of Schroeppel,
Oswego County, NY

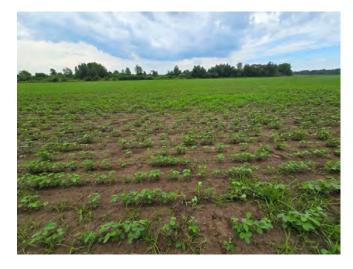
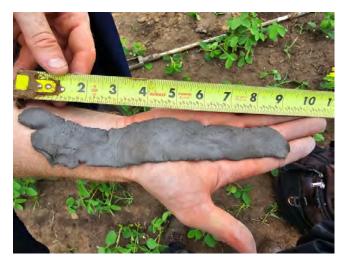
W-8 (showing clay that is present 35-inches below the surface)

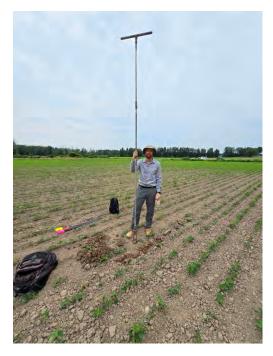
Profile Des Depth	scription: (Describe Matrix	to the de	epth needed to docur	ment the x Feature		r or conf	irm the absence	of indicators.)		
(inches)	Color (moist)	%	Color (moist)	%	Type <sup>1</sup>	Loc <sup>2</sup>	Texture	Remarks		
0-9	5YR 2.5/1	100	Color (molet)		.,,,,			Clay loam/oxidized root channels		
9-14	7.5YR 6/1	98	7.5YR 6/4	2				Reduced/depleted matrix		
<u>J-14</u>	7.511071		7.511(0/4					reduced/depicted matrix		
¹Type: C=	Concentration, D=De	bletion. RI	———— И=Reduced Matrix, C\$	S=Cover	ed or Coa	ted Sand	Grains. <sup>2</sup> Lo	ocation: PL=Pore Lining, M=Matrix.		
	il Indicators:	,	, ,					or Problematic Hydric Soils <sup>3</sup> :		
Histos	ol (A1)		Polyvalue Below	Surface	e (S8) ( <b>LR</b>	R R,	2 cm Mu	uck (A10) ( <b>LRR K, L, MLRA 149B</b> )		
Histic	Epipedon (A2)		MLRA 149B)				Coast P	rairie Redox (A16) ( <b>LRR K, L, R</b> )		
	Histic (A3)		Thin Dark Surface					ucky Peat or Peat (S3) (LRR K, L, R)

Site Name: Reed 1	Date: 06-21-2024
Landowner: The Wetland Trust	Designer Name: Thomas R. Biebighauser
The Wetland Trust Employees assisting with Johnston-Jordan	the design: Ed Frantz, Harrison Frantz, Kendall Hastings, Dylan
Objectives: Build a naturally appearing and functioning wetland for mitigation.	Site Description: An agricultural field planted to soybeans.
	es border all sides of the field. The deep ditch along the west side and ied drainage systems. Natural basins have been filled and the land
Plant species: Planted soybeans	How the planned wetland is marked on the ground: White wire flags
Invasive species: Reed Canary grass on neighboring private land.	Groundwater elevation in test hole? 9-foot 8-inches below the surface.
Hydric soil present near the surface? No	Elevation-change upper to lower edge of designed wetland: 2.0-feet
Test Hole location: 43.285713°N 76.229966° Soil texture: 0-7-inches = topsoil, 7-126-inch

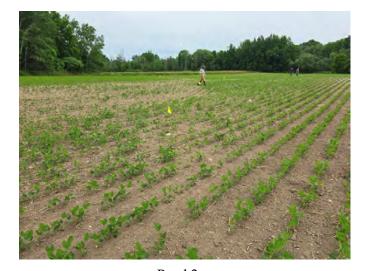
Reed 2 Reed 2

Construction notes: Build a groundwater dam along the lower perimeter of the wetland being built. Build an above ground dam that is no higher than 12-inches. Spread soil downhill. Add pits, scrapes, and mounds and then plant with native trees and shrubs.

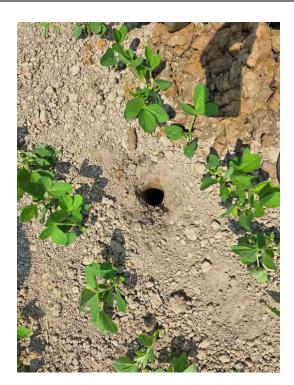
1. 2.				Number of Dominant Species That Are OBL, FACW, or FAC: (A)	)			
3. 4.				Total Number of Dominant Species Across All Strata: 2 (B)	)			
5.	·			Percent of Dominant Species That Are OBL, FACW, or FAC: 100.0% (A/	<b>(D)</b>			
6				That Are OBL, FACW, or FAC: 100.0% (A/	'В)			
··		=Total Cover						
Canling/Chruh Ctratum (Diat aire)		_ Total Cover		<del></del>				
Sapling/Shrub Stratum (Plot size:			E4 0)4/	OBL species 13 x 1 = 13

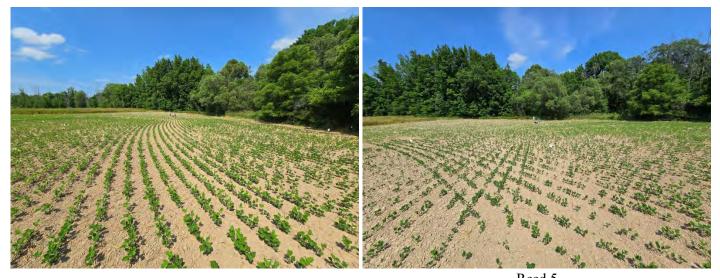
Reed 5

Construction notes: Build a groundwater dam along the lower perimeter of the wetland being built. Build an above ground dam that is no higher than 16-inches. Spread soil downhill. Add pits, scrapes, and mounds and then plant with native trees and shrubs.

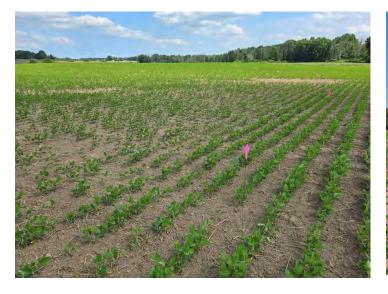
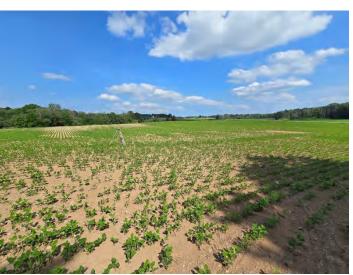
Reed 6 Reed 6

Construction notes: Build a groundwater dam along the lower perimeter of the wetland being built. Build an above ground dam that is no higher than 12-inches. Spread soil downhill. Add pits, scrapes, and mounds and then plant with native trees and shrubs.

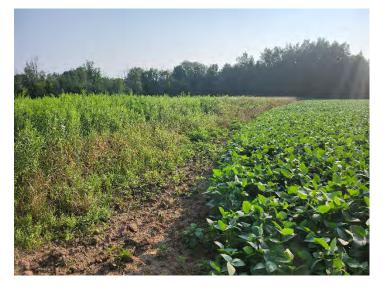
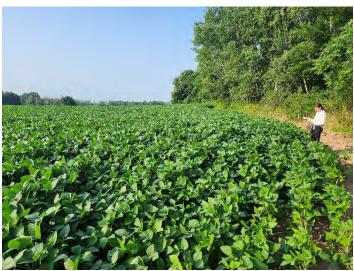
Reed 7 Reed 7

Construction notes: Build a groundwater dam along the lower perimeter of the wetland being built. Build an above ground dam that is no higher than 12-inches. Spread soil downhill. Add pits, scrapes, and mounds and then plant with native trees and shrubs.

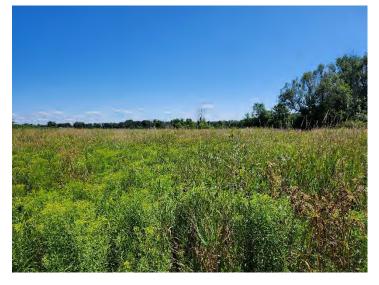
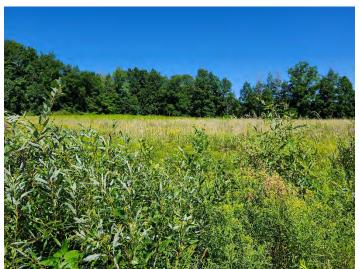
Reed 9

Construction notes: : Status of land for building needs to be determined. Build a groundwater dam along the lower perimeter of the wetland being built. Build an above ground dam that is no higher than 12-inches. Spread soil uphill. Add pits, scrapes, and mounds and then plant with native trees and shrubs.

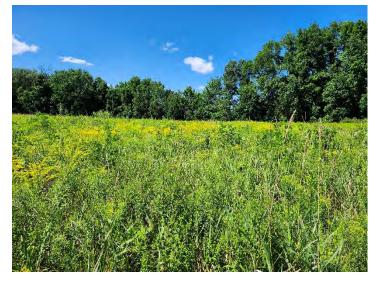
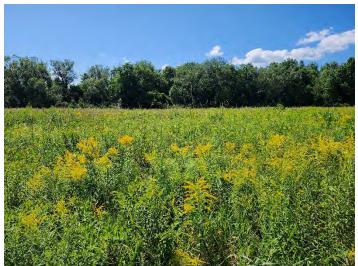
Reed 10 Reed 10

Construction notes: : Status of land for building needs to be determined. Build a groundwater dam along the lower perimeter of the wetland being built. Build an above ground dam that is no higher than 12-inches. Spread soil uphill. Add pits, scrapes, and mounds and then plant with native trees and shrubs.

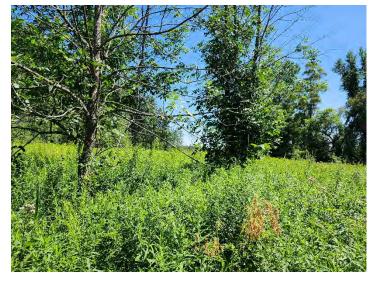
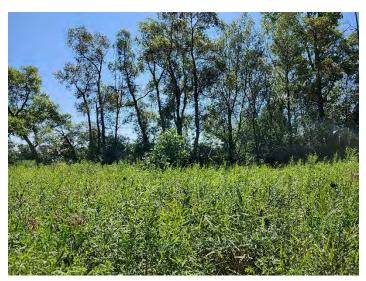
Reed 11 Reed 11

Construction notes: Status of land for building needs to be determined. Build a groundwater dam along the lower perimeter of the wetland being built. Build an above ground dam that is no higher than 12-inches. Spread soil uphill. Add pits, scrapes, and mounds and then plant with native trees and shrubs.

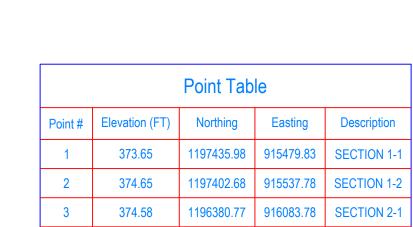
374.89 1197976.36 915040.04 SECTION 3-1

BASEFLOW CONDITIONS
